Queensferry  
Crossing

Project FORTH REPLACEMENT CROSSING

VIBRATION MONITORING REPORT

FEBRUARY 2017

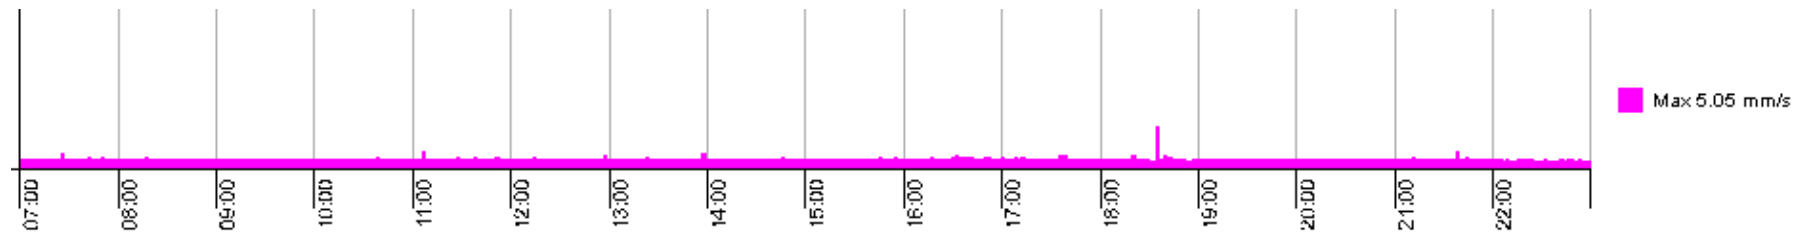
Exceedance on the 20th of February has been investigated and found to be caused by an isolated event that is unlikely to have been due to a construction related activity (graph above from the 20/02/2017).

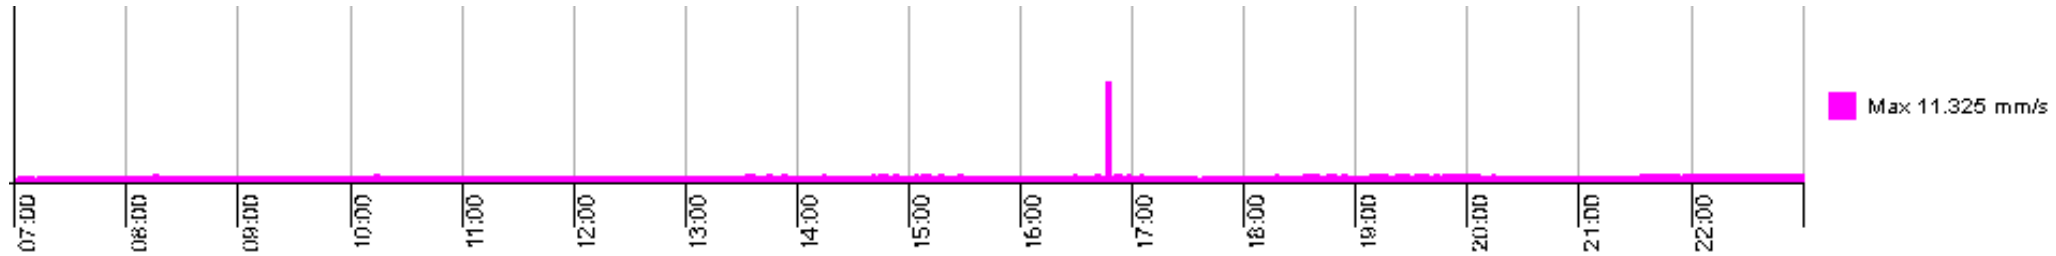
Exceedances on the 2<sup>nd</sup>, 5<sup>th</sup>, 18<sup>th</sup>, 20<sup>th</sup>, 22<sup>nd</sup>, 24<sup>th</sup>, 25<sup>th</sup>, 26<sup>th</sup>, 27<sup>th</sup> and 28<sup>th</sup> of February have been investigated and found to be caused by individual isolated events that are unlikely to have been construction related activities (graph above from the 02/02/2017). With this monitor being located in a public amenity area there is a likelihood that the exceedances seen above might have been caused by pedestrians using the area.

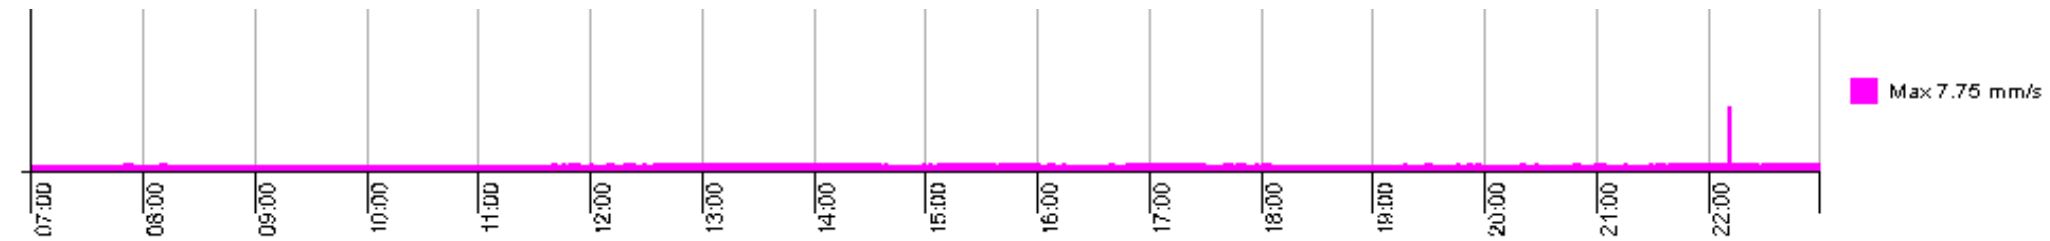
Exceedances on the 7<sup>th</sup>, 14<sup>th</sup> and 19<sup>th</sup> of February have been investigated and found to be caused out with construction working hours therefore it is unlikely that a construction related activity was the cause of these events (graph above from the 14/02/2017).

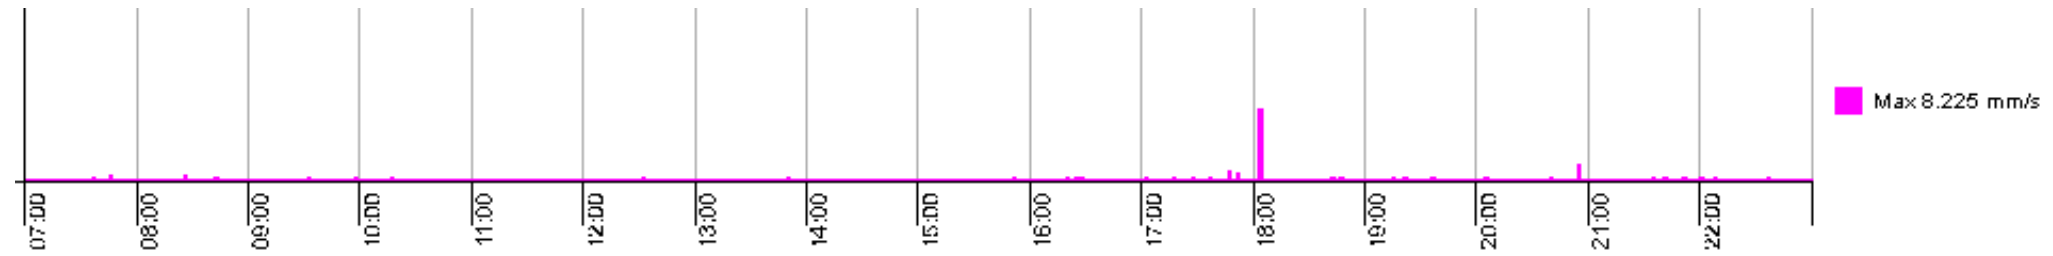
Exceedances on the 1<sup>st</sup>, 15<sup>th</sup>, 16<sup>th</sup>, 17<sup>th</sup>, 19<sup>th</sup>, 20<sup>th</sup>, 21<sup>st</sup>, 22<sup>nd</sup>, 25<sup>th</sup> and 27<sup>th</sup> of February have been investigated and found to be caused by individual isolated events that are unlikely to have been construction related activities (graph above from the 20/02/2017). The vibration monitor is located in the residents back garden, therefore resident's activity may have caused these exceedances.

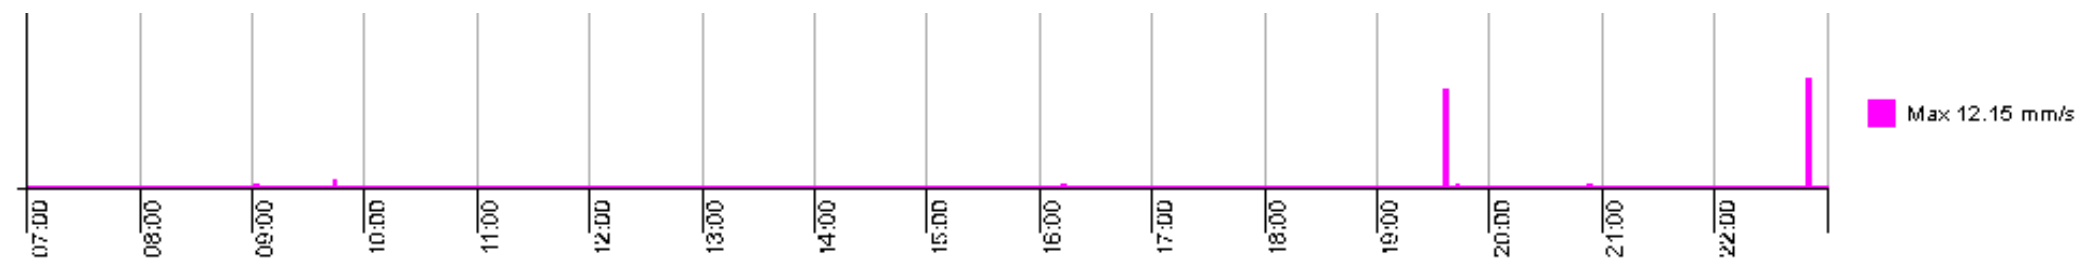
Exceedances on the 2<sup>nd</sup>, 3<sup>rd</sup> and 5<sup>th</sup> of February have been investigated and found to be caused out with construction working hours and therefore it is unlikely that a construction related activity was the cause of these events (graph above from the 05/02/2017).

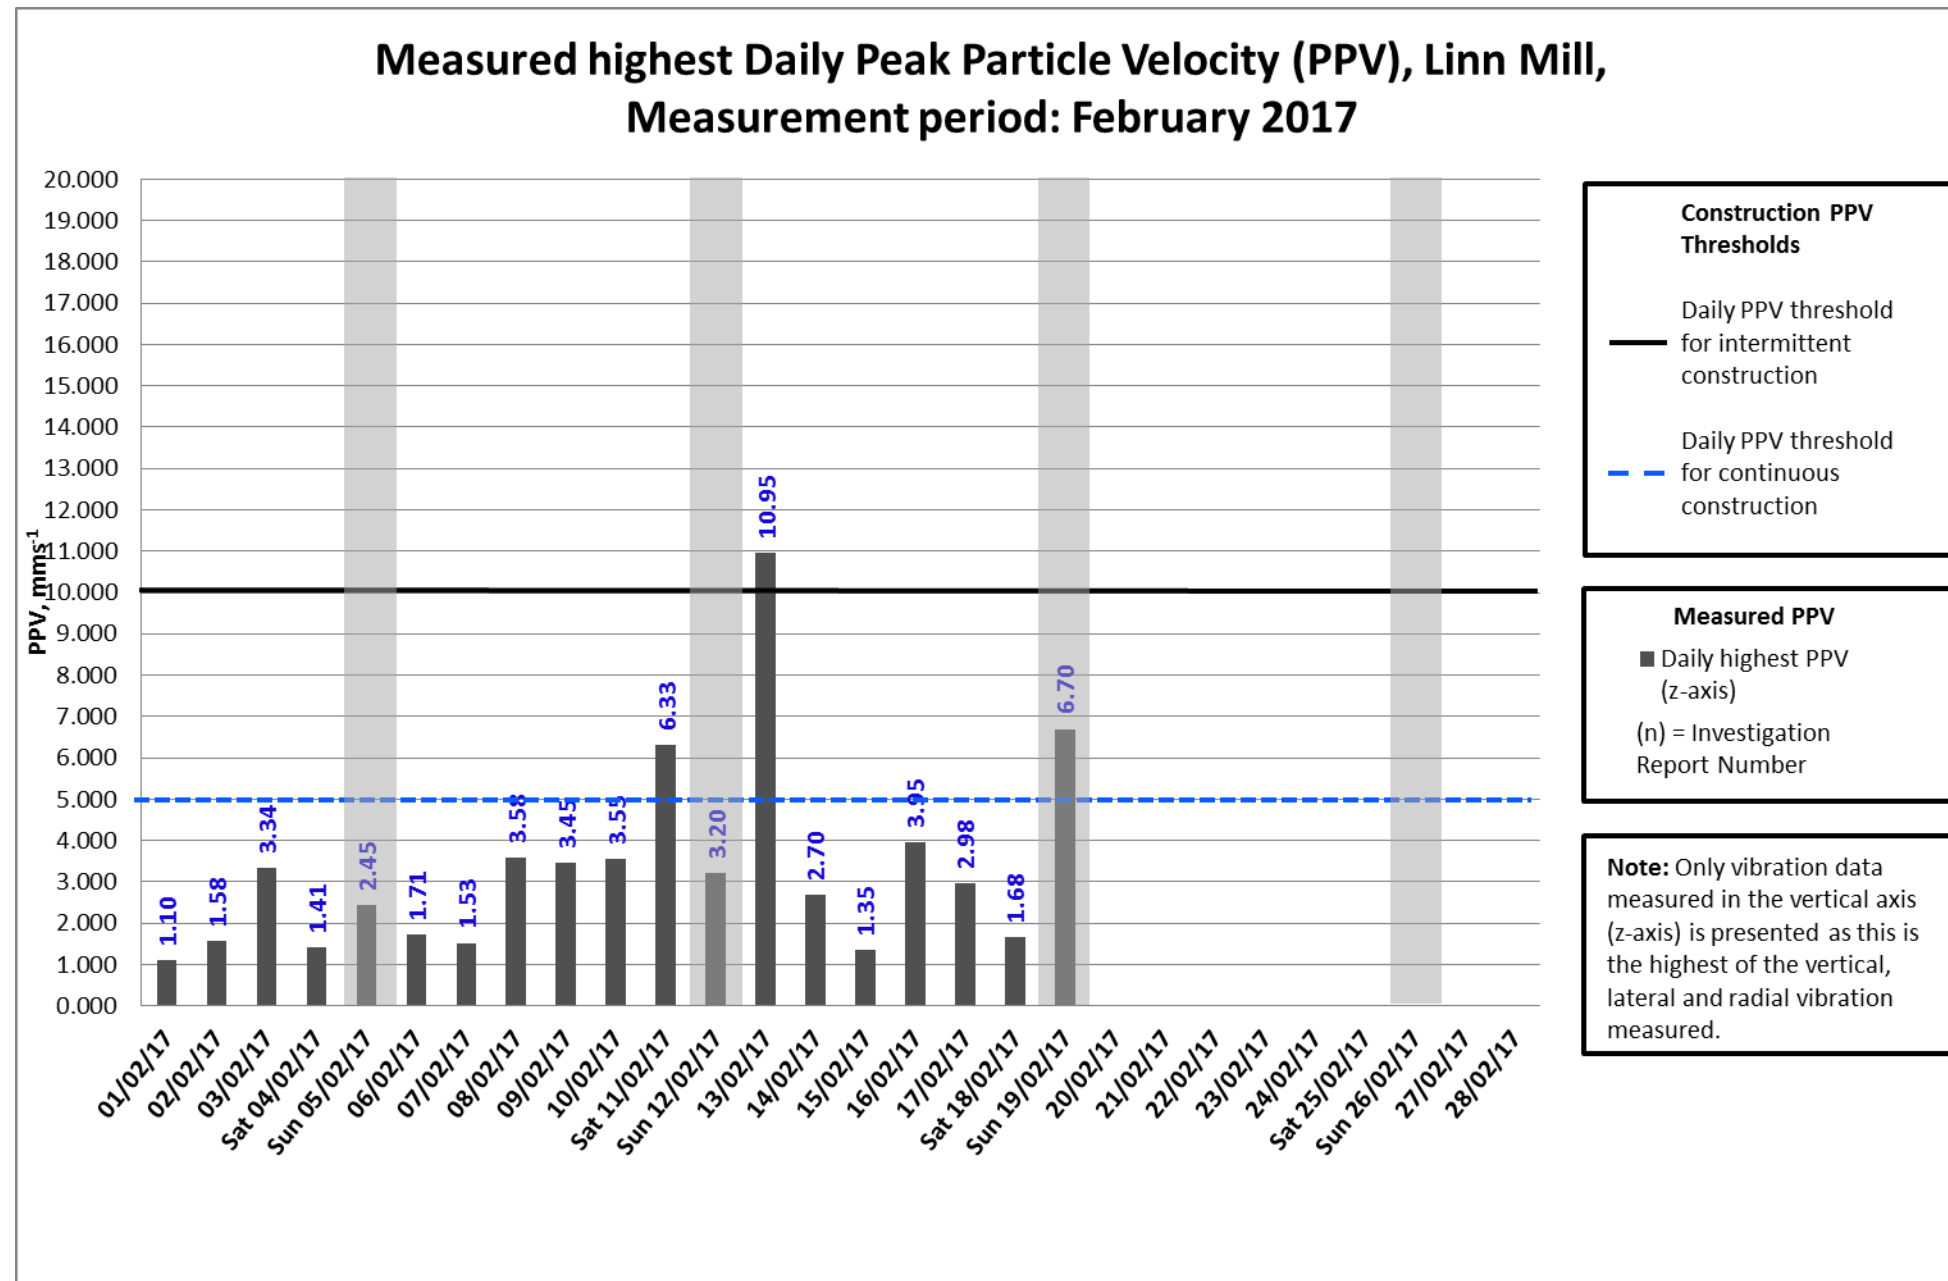
Data missing on the 20<sup>th</sup> – 28<sup>th</sup> February was caused by electrical issue with monitor.

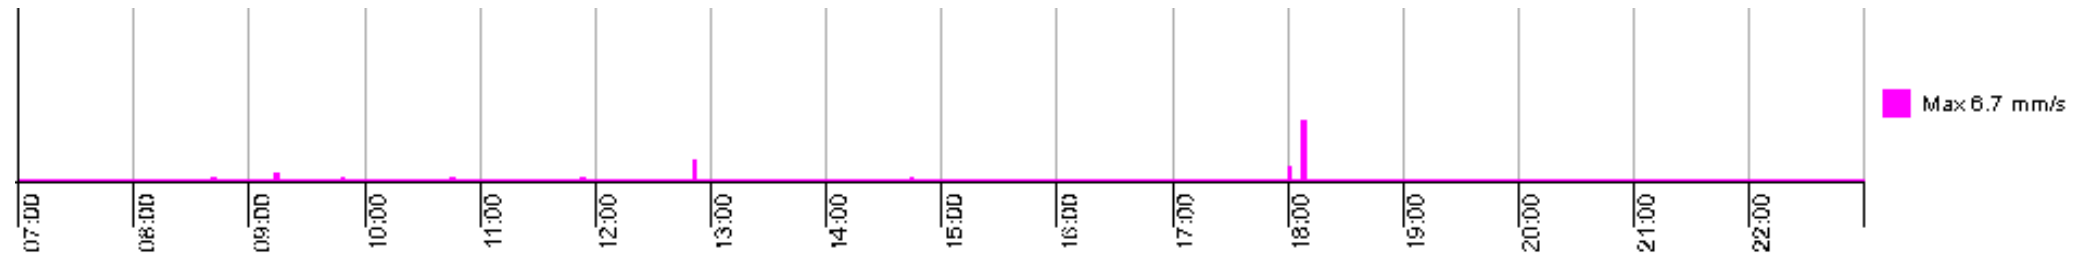
Exceedances on the 11<sup>th</sup>, 13<sup>th</sup> and 19<sup>th</sup> of February have been investigated and found to be caused by individual isolated events that are unlikely to have been construction related activities (graph above from the 19/02/2017). The monitor is situated in close proximity to the residents outdoor log store situated in the back garden. It is possible that these high readings were due to the residents fetching logs from this store area.

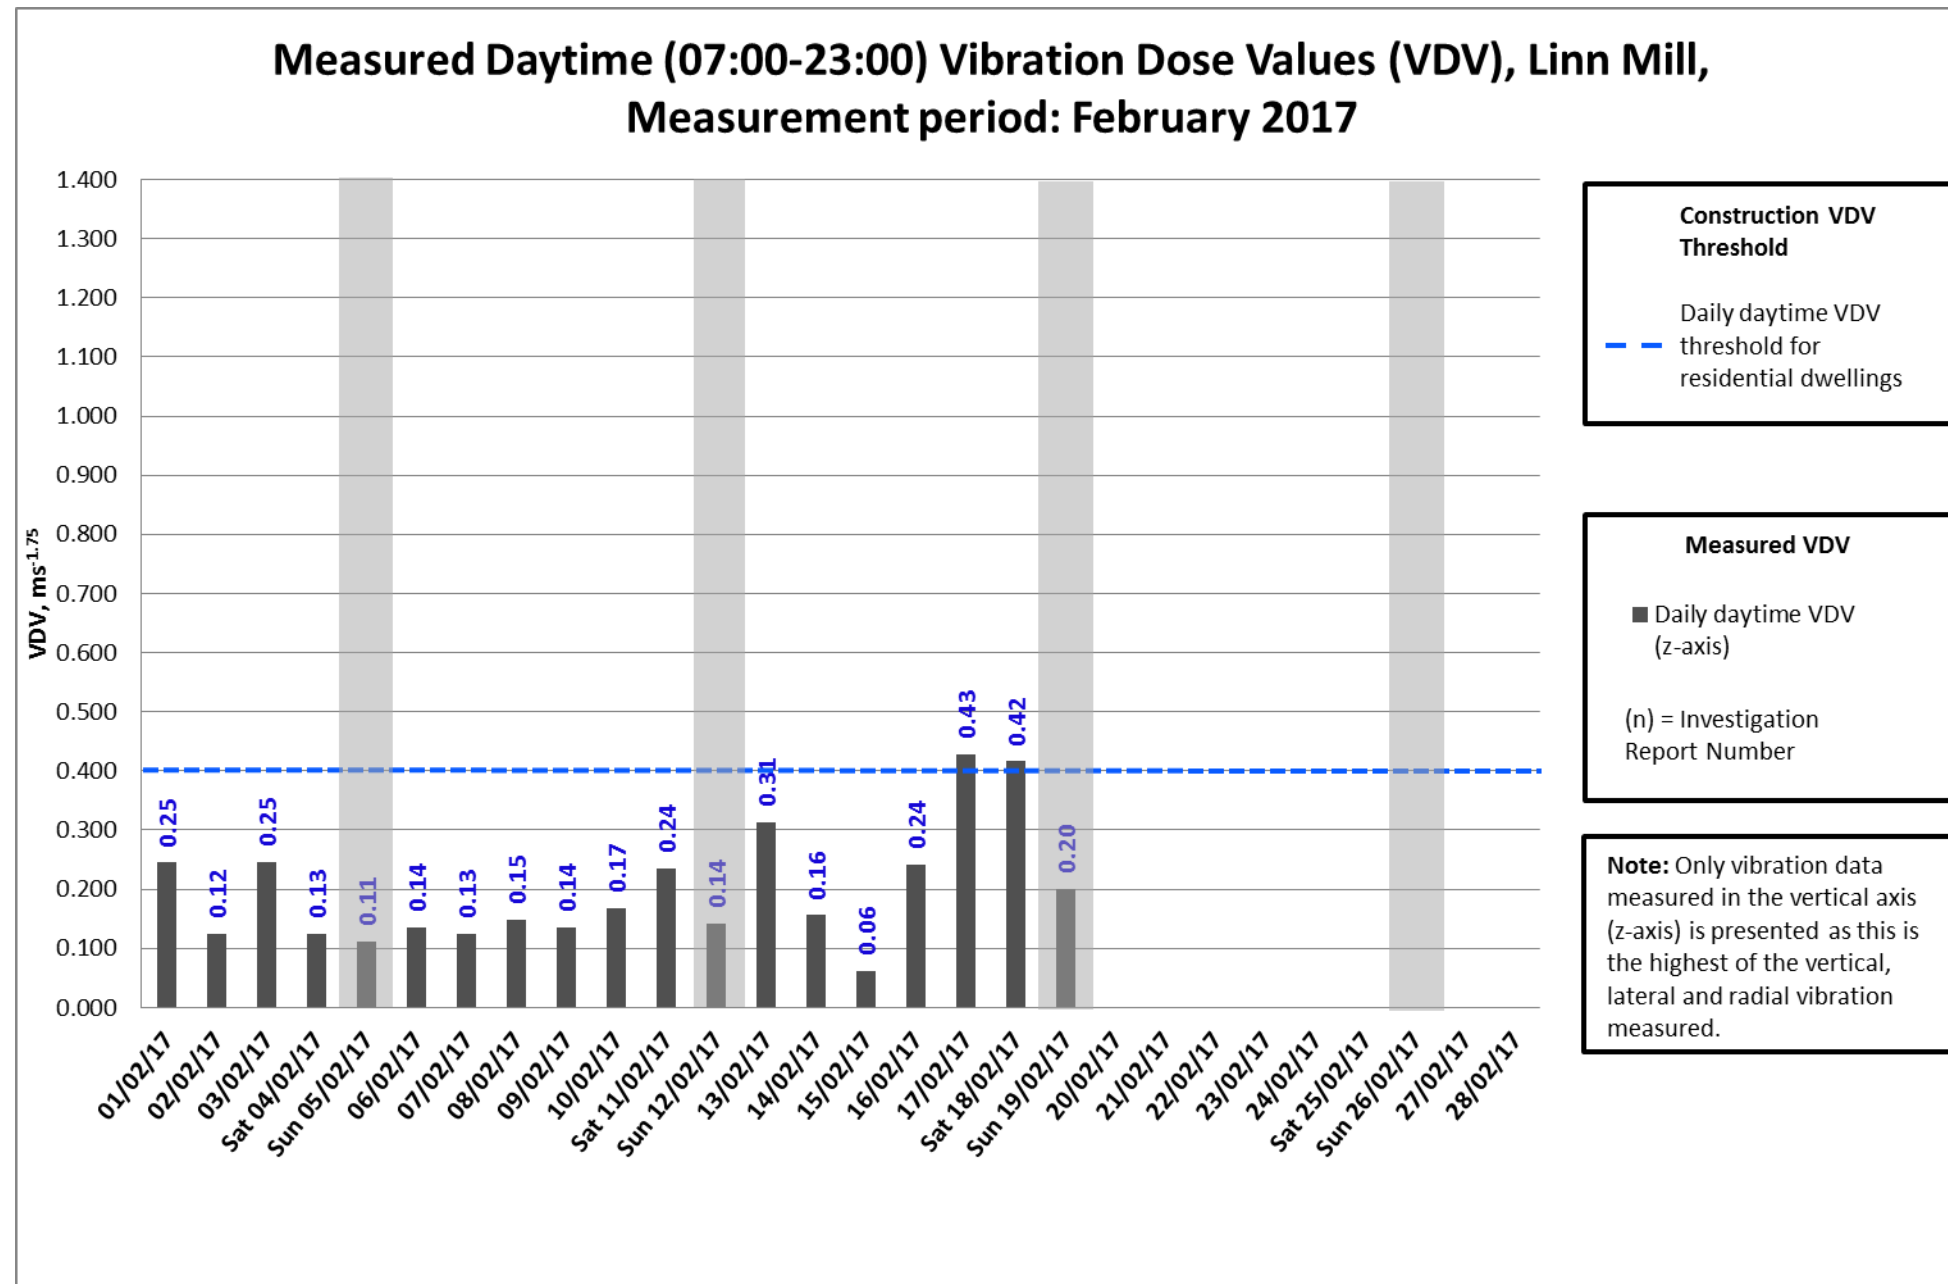
Data missing on the 20<sup>th</sup> – 28<sup>th</sup> of February was caused by electrical issue with monitor.

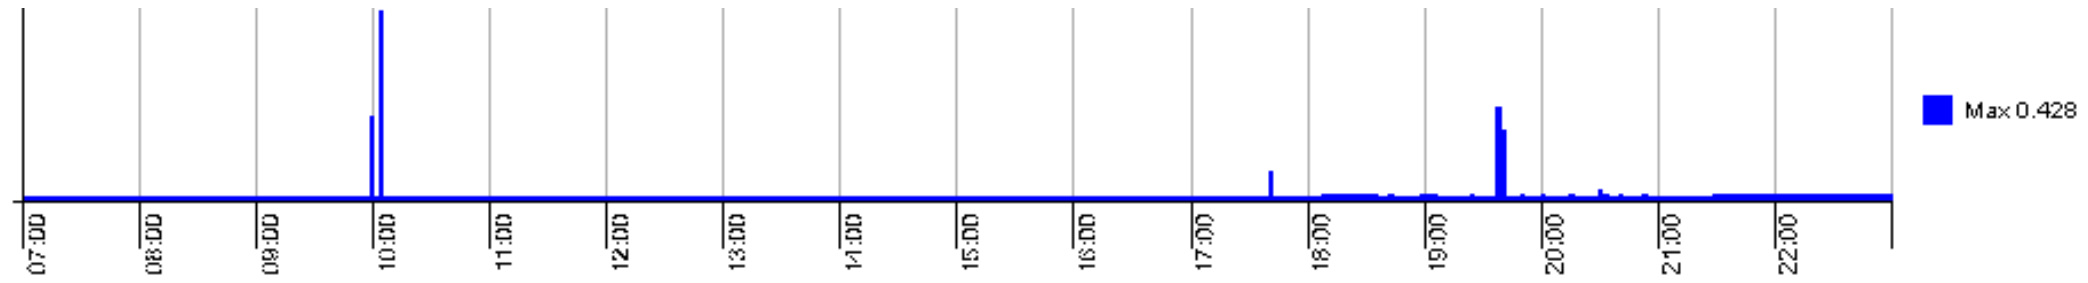
Exceedances on the 17<sup>th</sup> and 18<sup>th</sup> of February have been investigated and found to be caused by individual isolated events that are unlikely to have been construction related activities (graph above from the 17/02/2017).

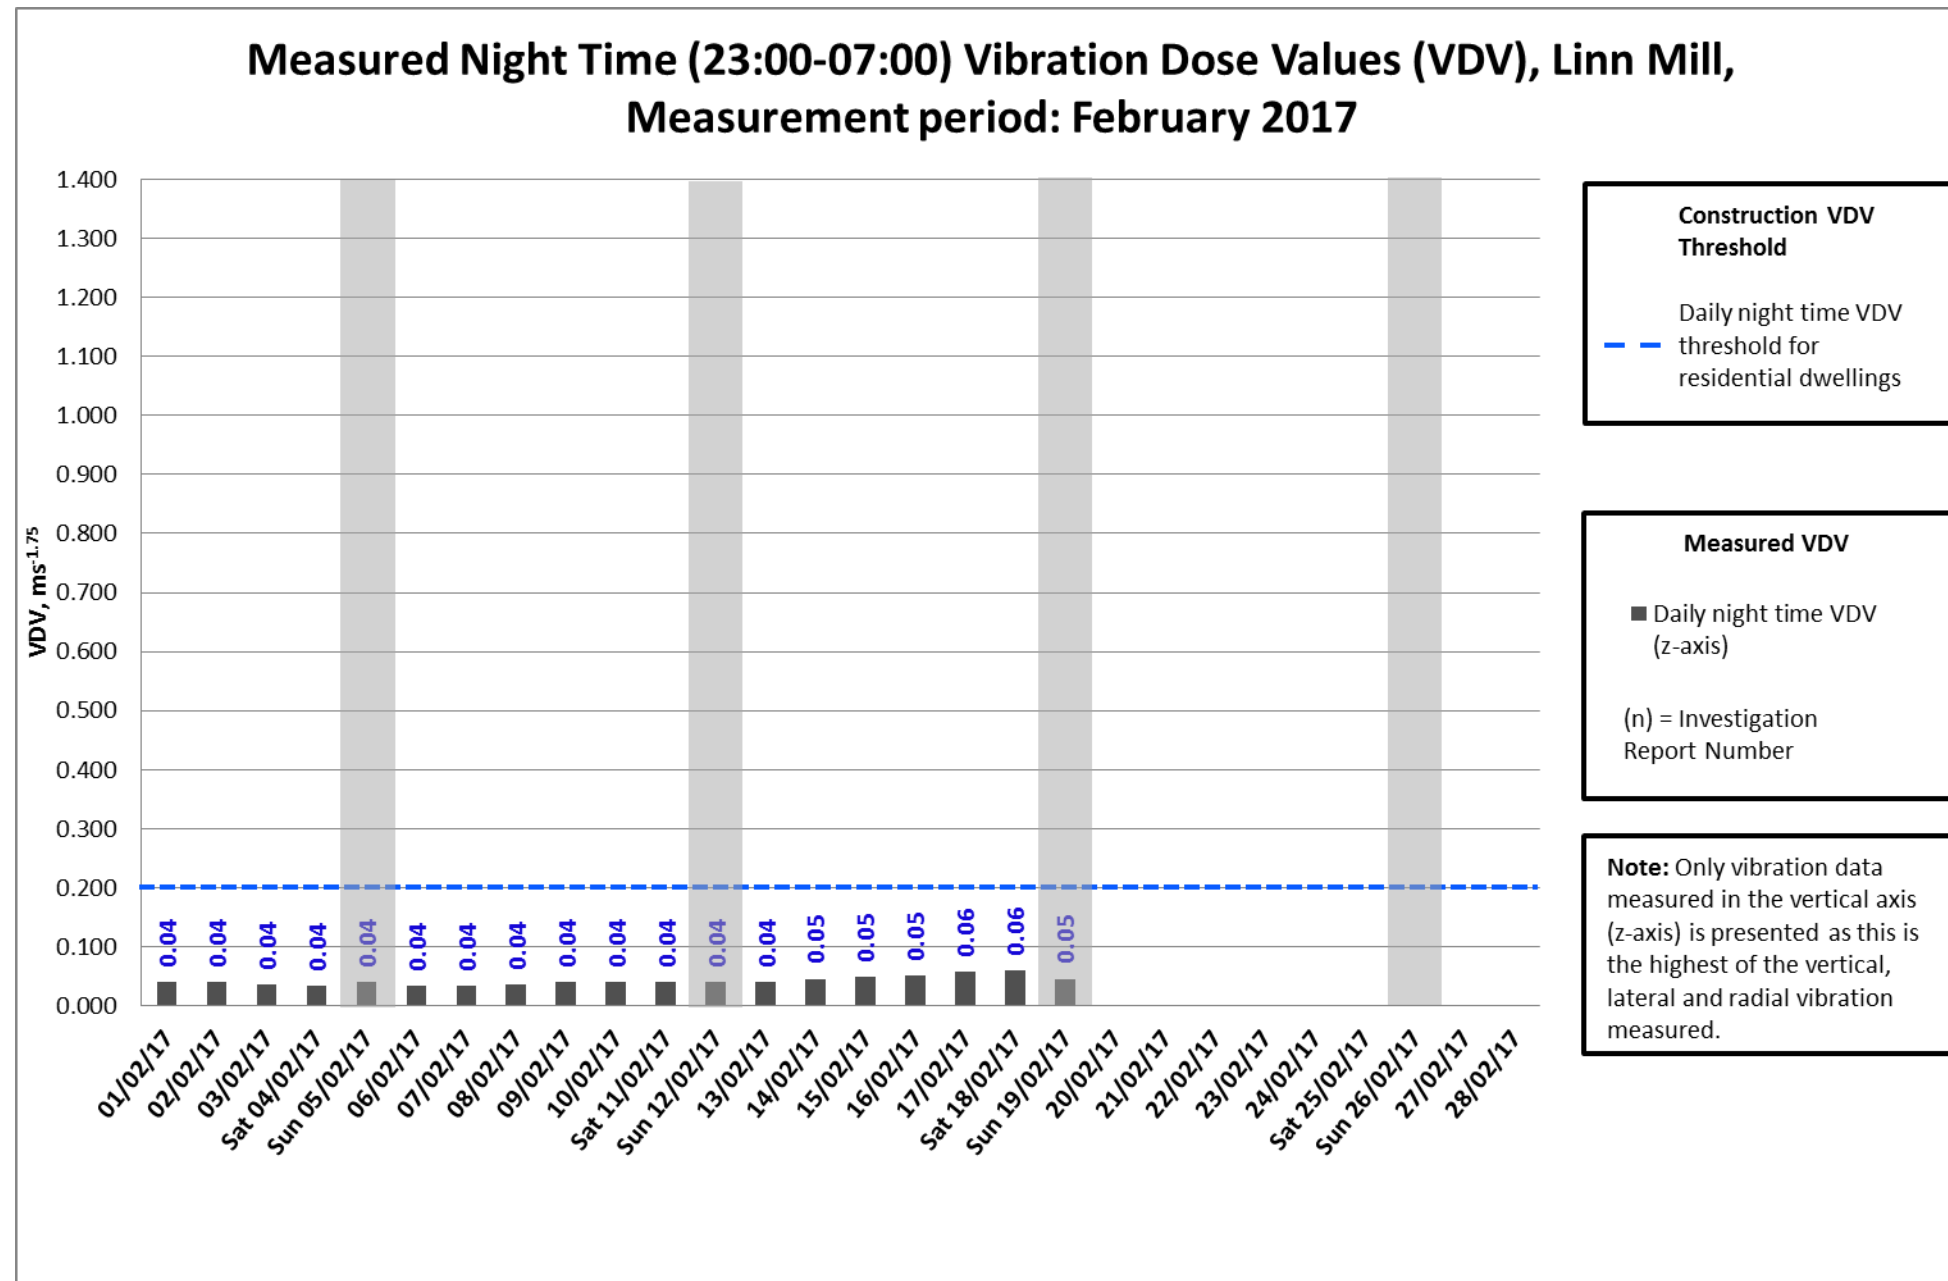
Data missing on the 20<sup>th</sup> – 28<sup>th</sup> of February was caused by electrical issue with monitor.

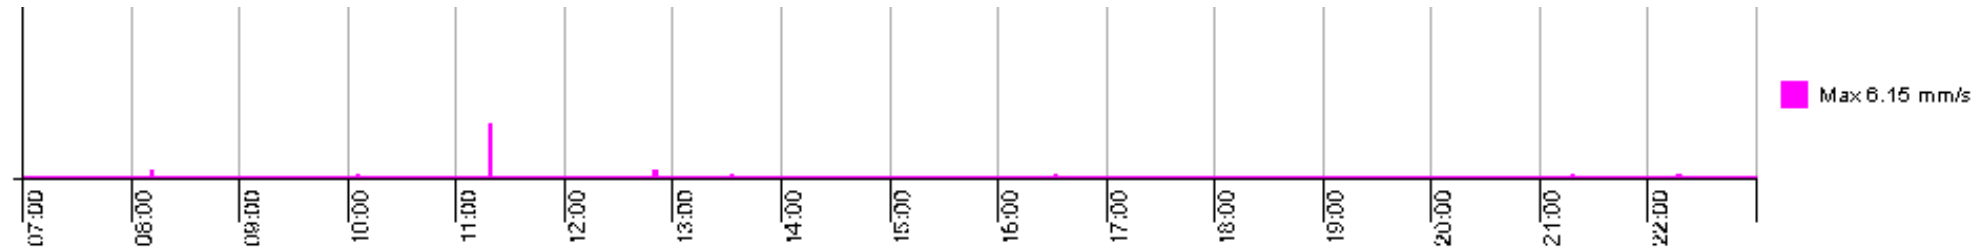
Exceedances throughout February have been investigated and found to be caused by individual isolated events that are unlikely to have been construction related activities (graph above from the 19/02/2017). The vibration monitor is located in the residents back garden, therefore resident's activity may have caused these exceedances.

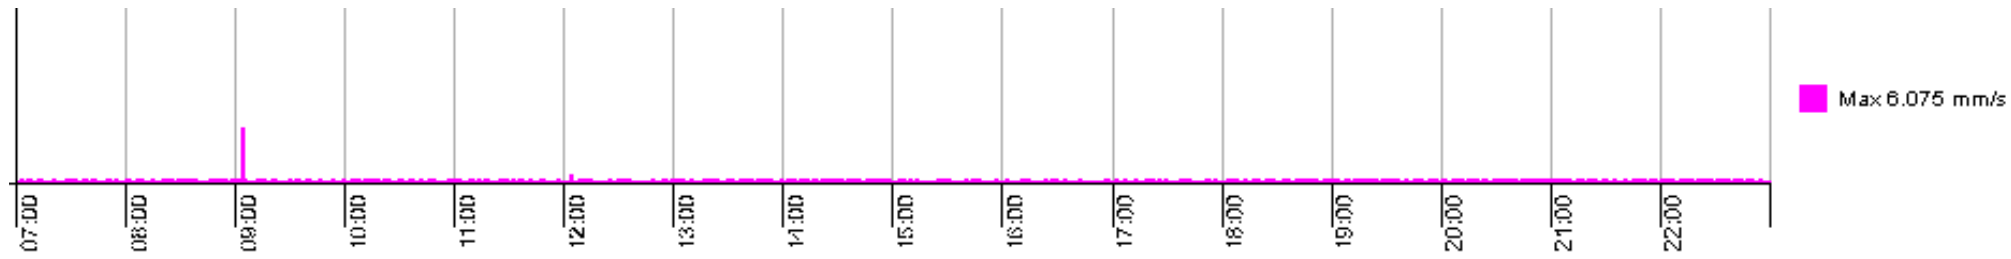
Exceedances on the 6<sup>th</sup>, 9<sup>th</sup>, 10<sup>th</sup>, 15<sup>th</sup>, 20<sup>th</sup> and 22<sup>nd</sup> of February have been investigated and found to be caused by the environmental department carrying out maintenance on noise monitor (graph above from the 15/02/2017).

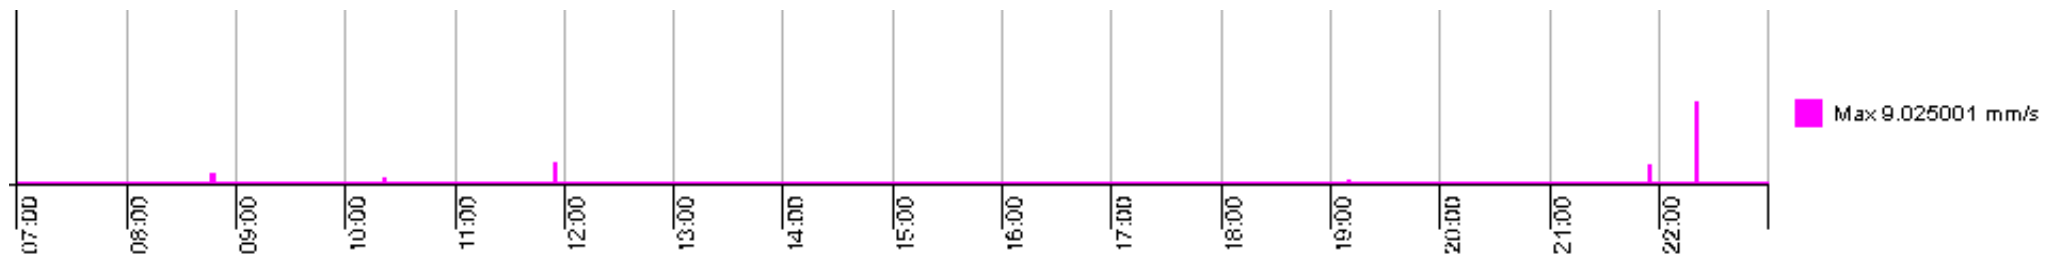
Exceedances on the 8<sup>th</sup>, 14<sup>th</sup> and 18<sup>th</sup> of February have been investigated and found to be caused out with construction working hours and therefore it is unlikely that a construction related activity was the cause of these events (graph above from the 18/02/2017).

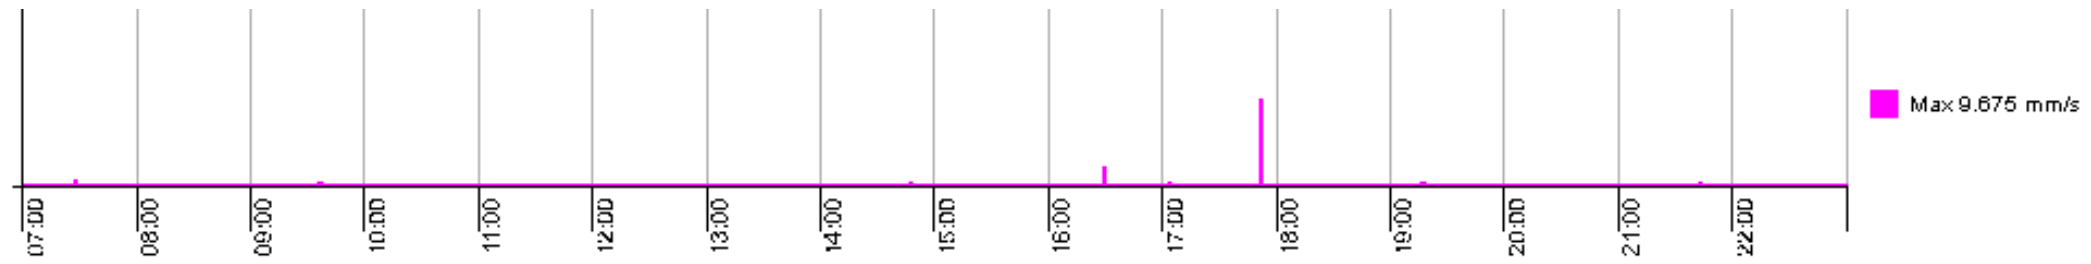
Exceedances on the 4<sup>th</sup>, 5<sup>th</sup>, 8<sup>th</sup>, 10<sup>th</sup>, 22<sup>nd</sup>, 23<sup>rd</sup>, 24<sup>th</sup>, 25<sup>th</sup>, 26<sup>th</sup> and 27<sup>th</sup> of February have been investigated and found to be caused by individual isolated events that are unlikely to have been construction related activities (graph above from the 05/02/2017).

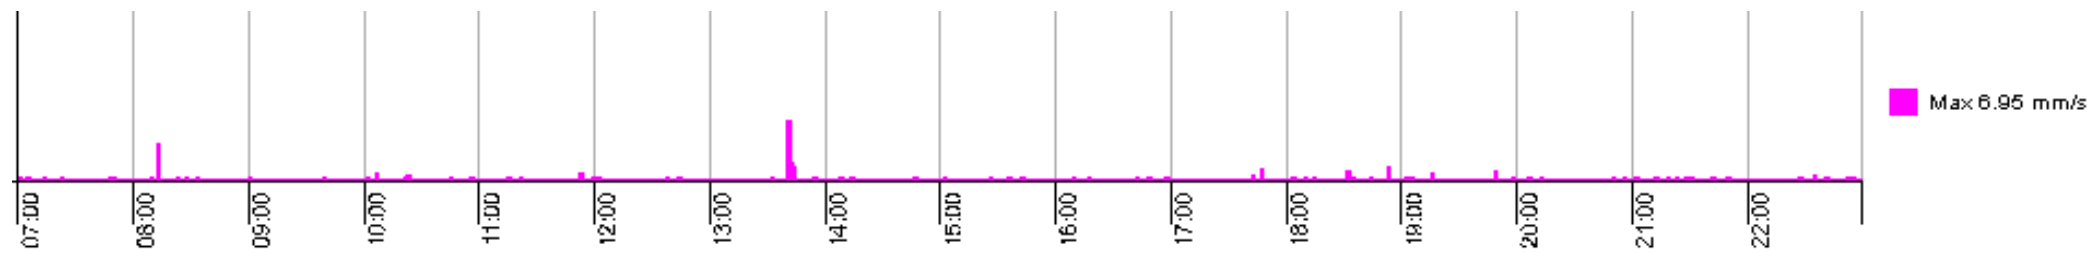
Exceedances on the 6<sup>th</sup>, 20<sup>th</sup>, 21<sup>st</sup> and 28<sup>th</sup> of February have been investigated and found to be caused by the environmental department carrying out maintenance on noise monitor (graph above from the 28/02/2017).

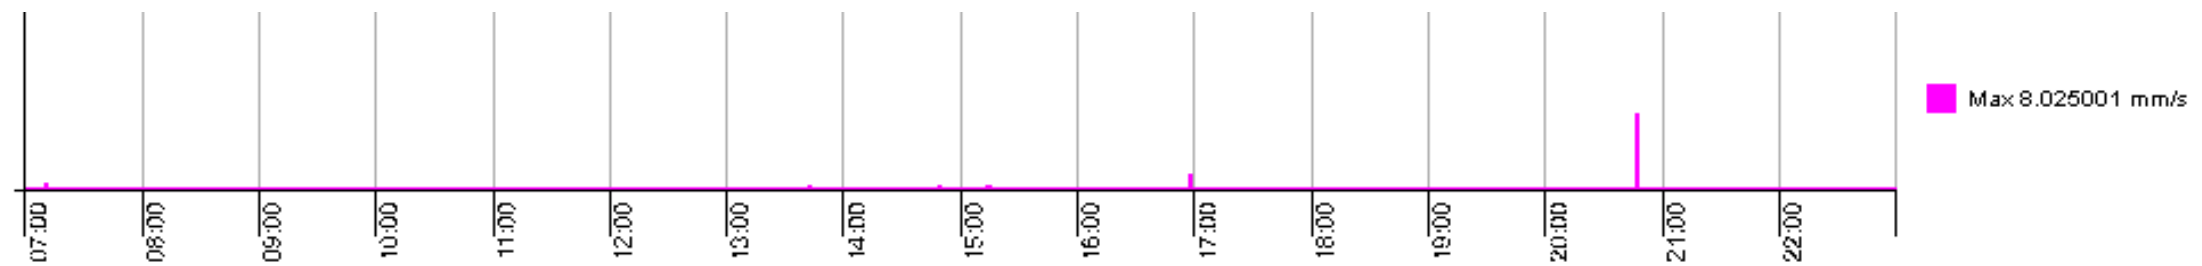
Exceedances on the 7<sup>th</sup>, 9<sup>th</sup>, 11<sup>th</sup> and 13<sup>th</sup> of February have been investigated and found to be caused out with construction working hours and therefore it is unlikely that a construction related activity was the cause of these events (graph above from the 07/02/2017).
