# THE PERFORMANCE OF ROAD SURFACING IN SCOTLAND

Scottish Inspection Panel Report 2023

**PROJECT NO. 70061042**

**DATE: SEPTEMBER 2023**

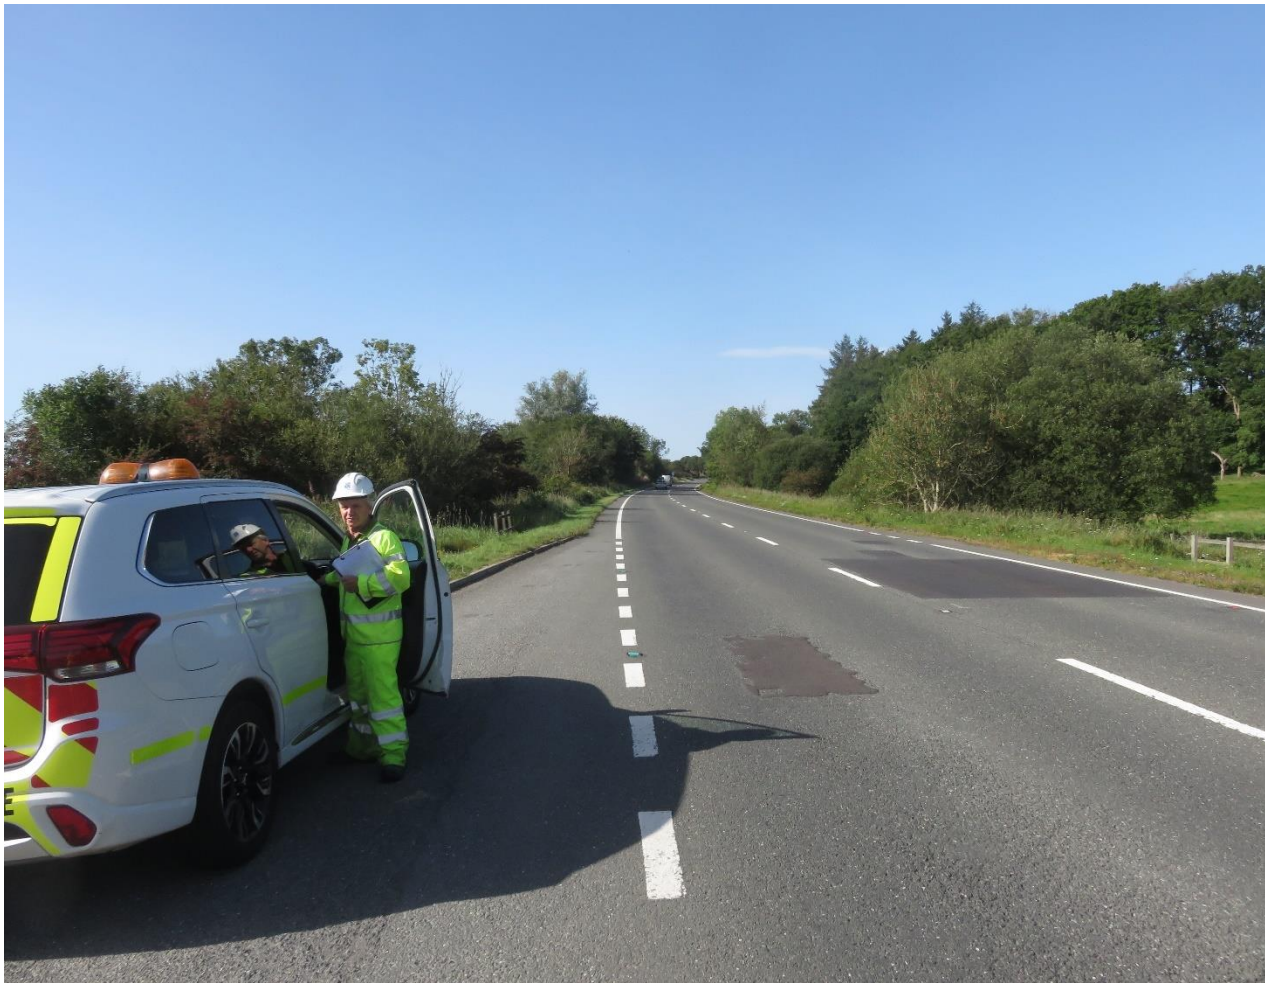
**Figure 4-1 – Cold load ends at IP16**

If asphalt is allowed to cool to too low a temperature, then adequate compaction will not be achieved on site. The affected material will possess a lower density and higher air voids content when compared to the rest of the mat. These areas are often referred to as '*cold spots*' and are known to retain water following rainfall and take longer to dry out. Moisture damage is known to cause ravelling or disintegration of the asphalt mortar leading to aggregate loss. Figure 4-1 shows two distinct areas where cold spots have been replaced at site IP16. The bottom right-hand corner of the image shows material with an open texture that is continuing to deteriorate. The PMS system AMPS, shows that IP16 received a structural inlay containing 220mm of base and binder material, and supports the observation that the defects are confined to the surfacing.

It is intended that the recent introduction and use of digital technology (McHale, *et al*) will be used to monitor and improve the quality of asphalt paving in Scotland.

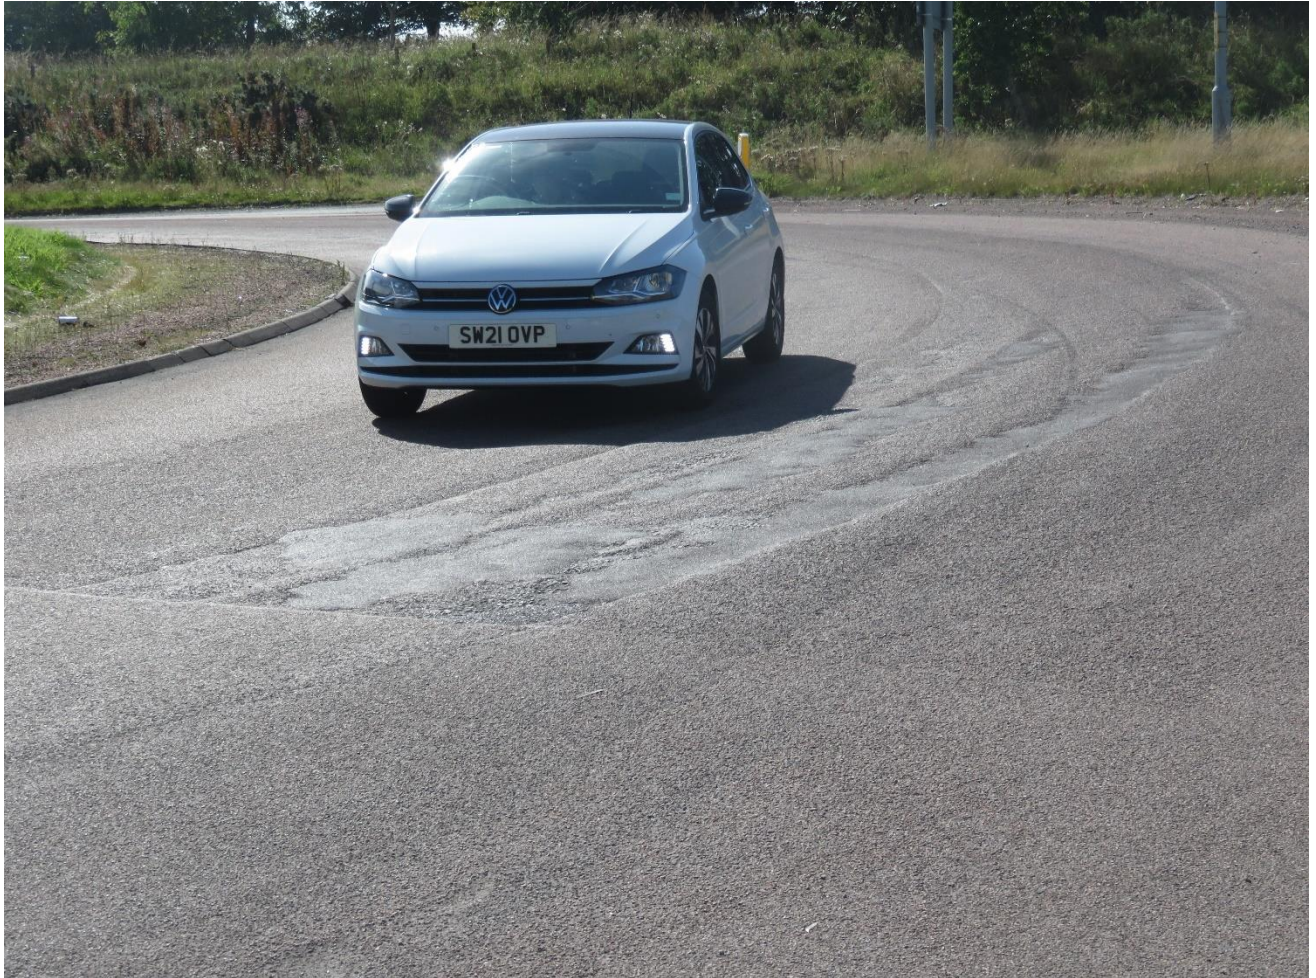
**Figure 4-2 - Roundabout surfacing failure at IP40b**

Figure 4.2 shows that a 6mm TS2010 surface course at IP40b has stripped under the braking and turning stresses imposed by HGVs. A recommendation of the 2021 SIP survey was to review the performance of surfacing on roundabouts to ensure that the optimum mixtures were being selected and installed correctly. A second roundabout site (IP36) also contained a 6mm TS2010 and was reported to have been replaced after only two years in service. It has been speculated that the surface characteristics of 6mm mixtures may provide enhanced grip that renders them vulnerable to high shear stresses and subsequent stripping under heavy traffic. Anecdotal evidence suggests that 10mm mixtures may perform better than 6mm mixtures. Where particularly high turning stresses are anticipated, it is possible that an HRA surface course may provide the most durable solution.

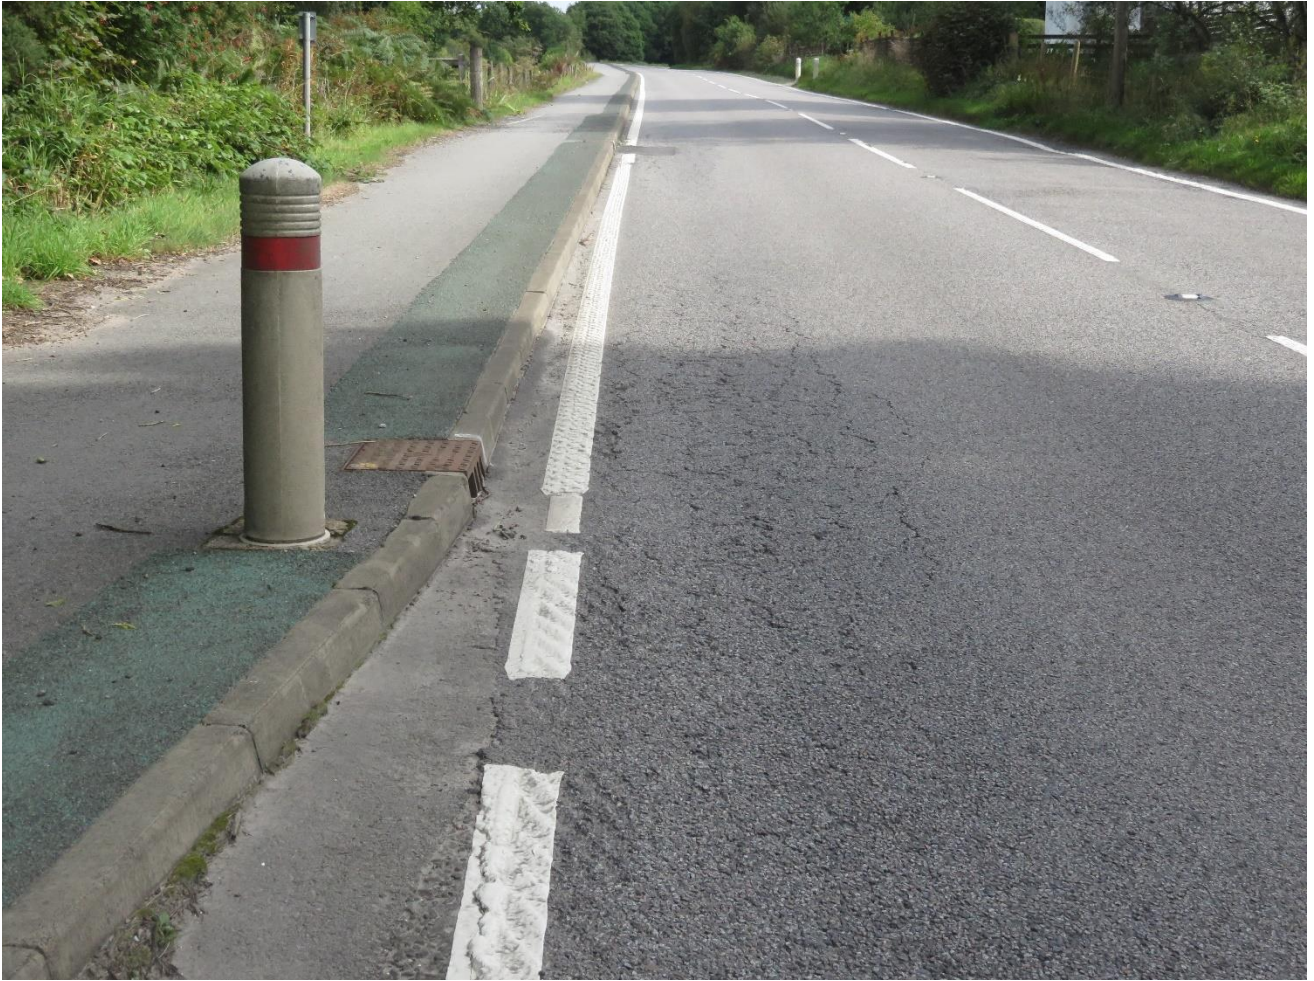
**Figure 4-3 - Poor structural support at IP27**

Some of the schemes visited exhibited defects in areas where a shallow inlay had been selected in preference to a deeper inlay. Figure 4-3 shows defects at Site IP27 which are associated with inadequate structural support. According to AMPS, Site IP27 was treated with a 50mm inlay. In this particular instance, the SIP team had access to video footage of the scheme prior to treatment being

carried out. The video footage clearly showed that the foundation in this area was weak. This site highlights the importance of conducting a rigorous pavement assessment as part of the design process and the need to address areas identified as providing poor foundation support.

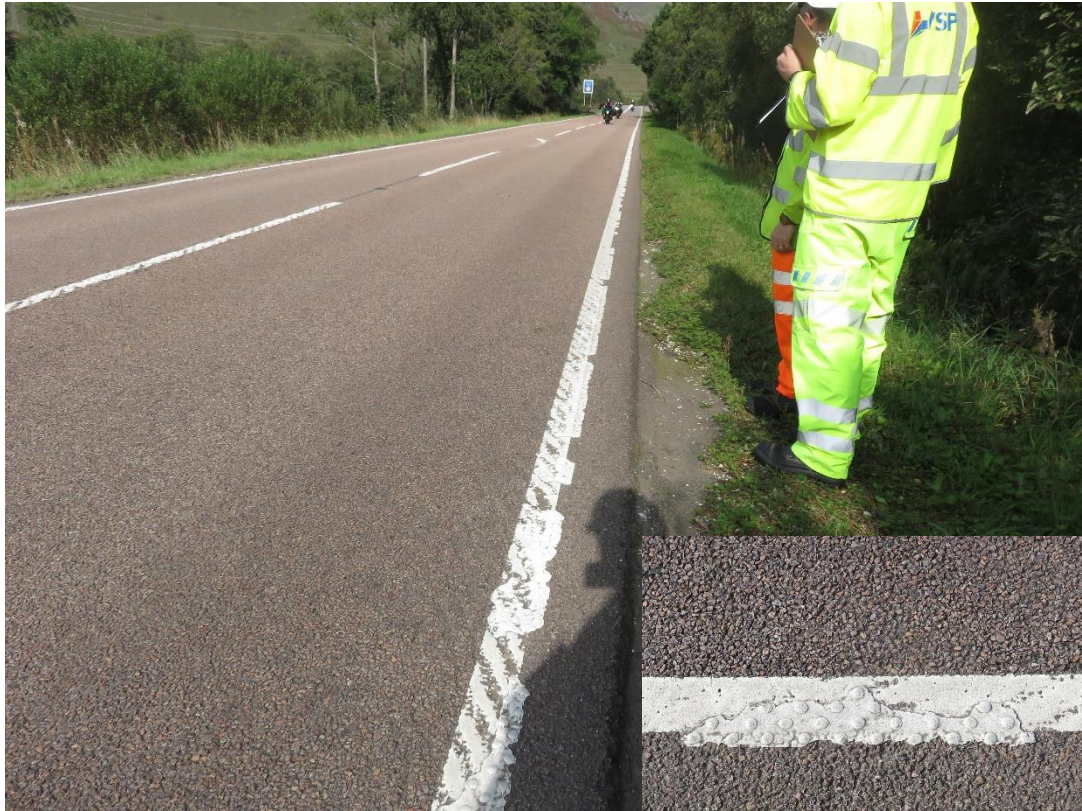
Two observations were made in association with carriageway markings: delamination and mechanical scouring. The former related to new carriageway markings that had failed to bond with the previous marking material that had not been removed. Figure 4-4 shows a significant length of material that had debonded, and the insert shows a close-up of some of the new material that was retained. The latter observation concerned the mechanical technique employed to remove existing carriageway markings. As shown in Figure 4-5, the method resulted in the diagonal abrasion or scouring of the existing surface course material. In some instances, the road surfacing material had been damaged with the removal material.

**Figure 4-4 - Delamination of new marking material at IP25**

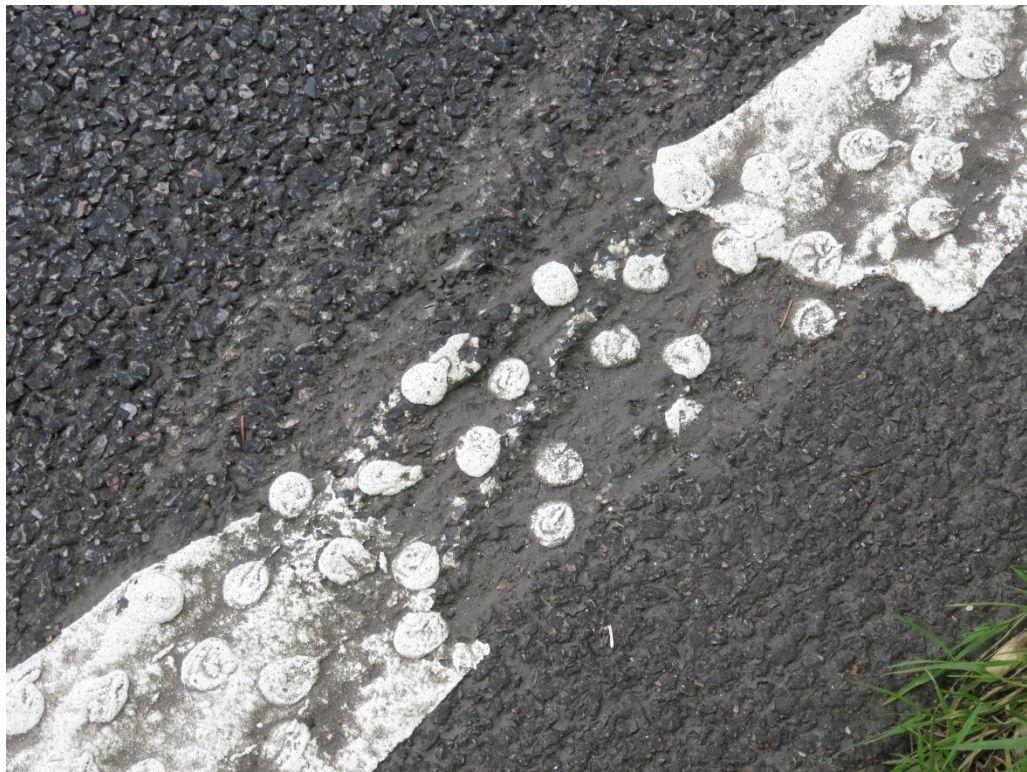
**Figure 4-5 - Mechanical damage to surface course at IP28**

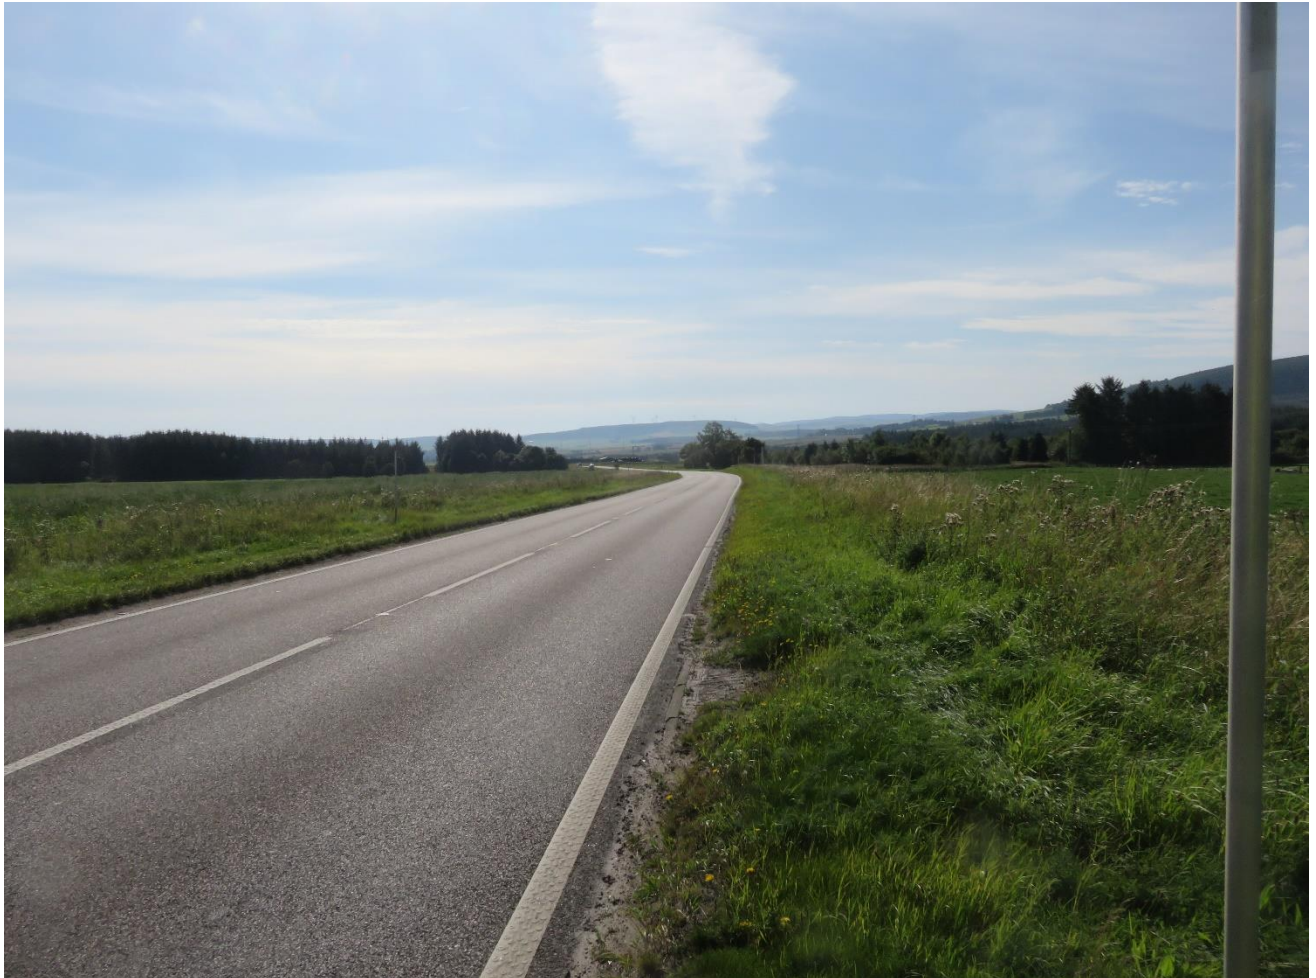
Eighty-seven percent of the sites were assessed to be Good or Excellent by the panel and over a third of these sites (16) were assessed as Excellent. The latter mark is only given if the material inspected is assessed to be defect free. Figure 4-6 shows one of the sites that was assessed to be defect free. These positive results confirm that TS2010 provide enhanced durability when compared to some Clause 942 materials and those inspected during previous surveys.

**Figure 4-6 - IP37 assessed to be defect free after 5.3 years in service**

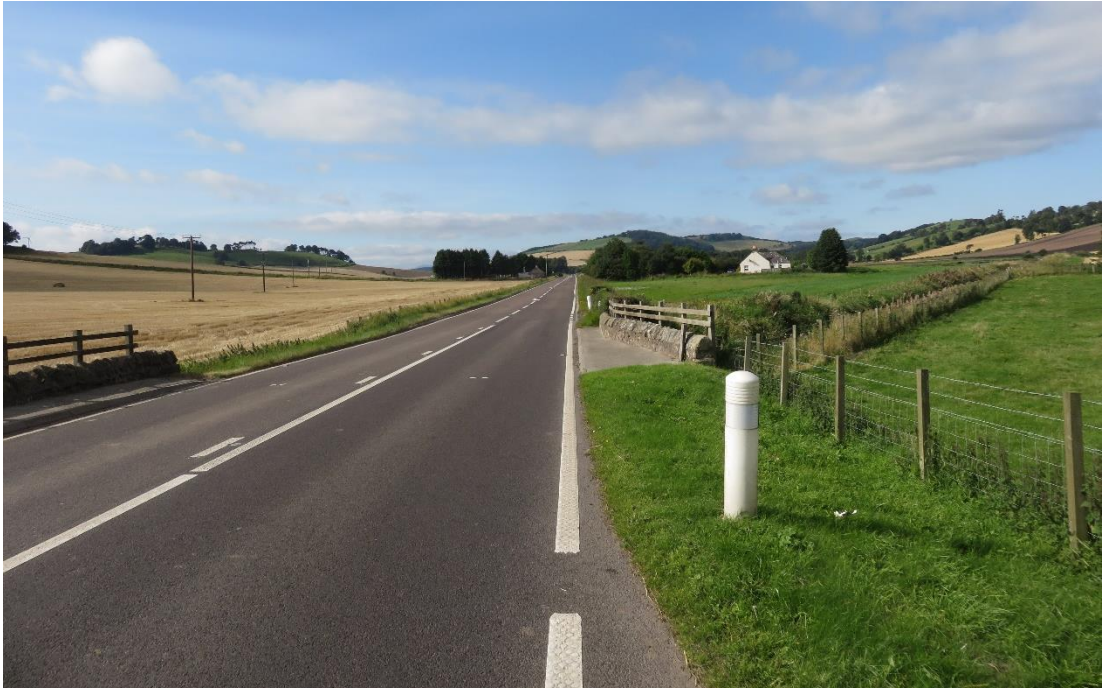
**Figure 4-7 - Sol4: Biogenic binder, assessed Excellent**

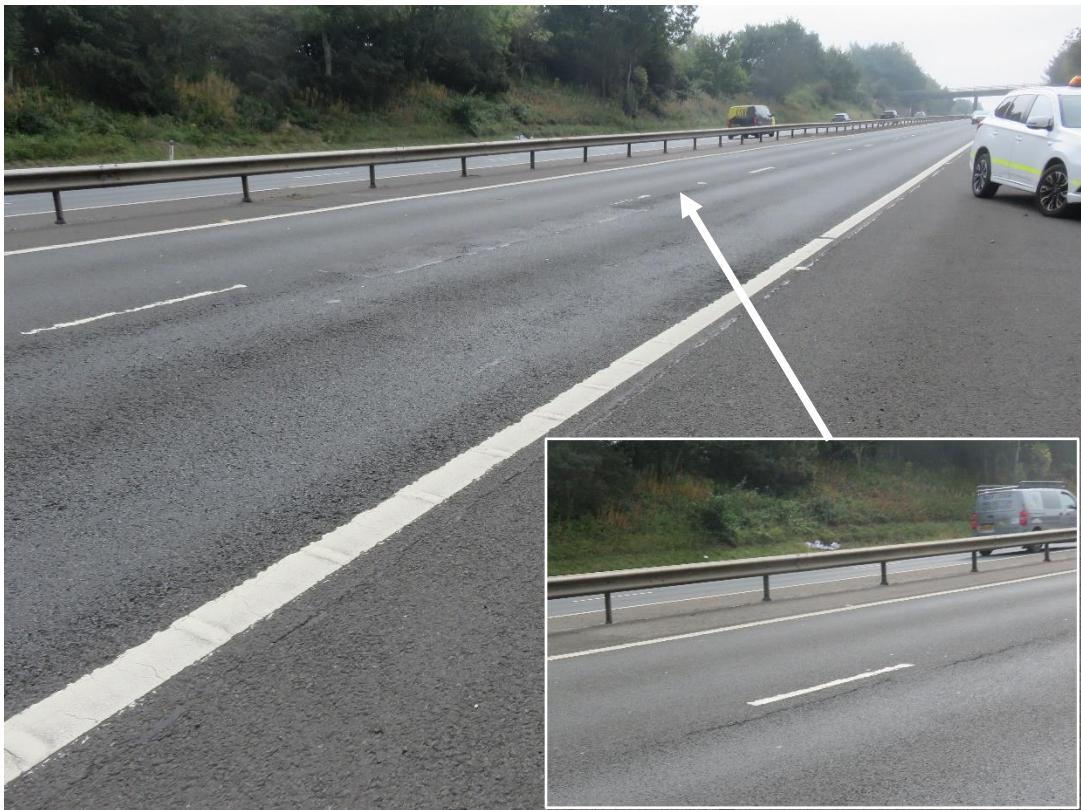
At the request of Transport Scotland, three additional sites of interest (Sol) were visited as part of the 2023 survey. One of the sites contained a new surface course that contained a biogenic binder which was being trialled on a section of the A92. The mat shown in Figure 4-7 was assessed as Excellent by the panel and was defect free at the time of the inspection. The second site was located on the M9 and contained a TS2010 which was laid in 2013. The site was given an overall Acceptable mark with faults including cracking, aggregate loss, variability and joint defects. The site is shown in Figure 4-8 and exhibited defects associated with cold loads. However, on closer inspection, longitudinal cracking (insert, bottom right) was noted indicating possible structural issues. The third site contained a four-year-old surface course that contained rubber from recycled tyres. The site was assessed as Medium with faults including aggregate loss, variability and open joint.

**Figure 4-8 - Sol1: 10-year-old TS2010 assessed A c v – Jo**
