Appendix A12.3

Aquatic Ecology

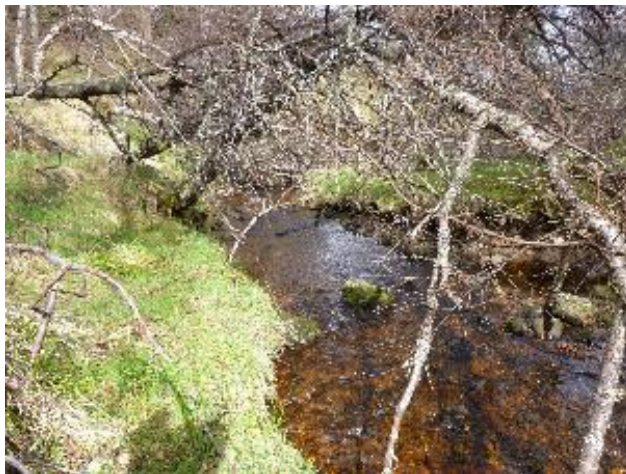
P1000096 - downstream of A9

- Summary: The reach provides a variety of glide, pool and riffle habitat (within the context of a minor channel). The lack of optimal spawning habitat, size of the channel and water depth observed at survey are likely to limit the salmonid use of this habitat resource. Undercut banks and Large Woody Debris (LWD) locally improve fish habitat diversity. Small numbers of juvenile salmonids were observed during freshwater pearl mussel surveys in this reach (see Annex E). Other lithophilic gravel spawners such as common minnow and lamprey may be present in low numbers, given habitat suitability, in addition to eurytopic species such as European eel. However species diversity is likely to be low, as is common for upland rivers of this type.

- Biological metrics are indicative of good habitat diversity and water quality, high flow velocity conditions and low channel sedimentation.
- The CCI scoring system is used to assess the intrinsic conservation importance of the community present. CCI scores of 5.08 and 10.00 were recorded from respective sites, which are considered to be communities of 'Moderate' and 'Fairly High' conservation importance under the system.

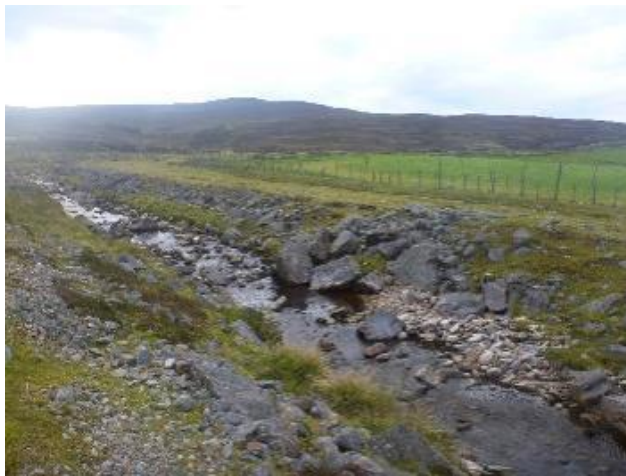
Watercourse: Dalmagarry Burn (Ch3600)	Central NGR: NH 78747 32182

<p data-bbox="284 750 622 784">P1030800 – upstream of A9</p>	<p data-bbox="933 271 1316 304">Baseline Ecological Valuation</p> <p data-bbox="933 309 1428 342"><i>Local</i> importance for nature conservation.</p> <p data-bbox="933 347 1436 806">The Dalmagarry Burn has been historically realigned but shows signs of natural recovery. Dynamic fluvial processes have given rise to a range of habitats that are likely to be locally important in supporting fish assemblages, and wider ecological communities. A 2011 FNLFT electric fishing survey approximately 600m upstream of the existing A9 crossing identified salmon and trout fry and parr. It also supports a species-rich macroinvertebrate community indicative of good quality habitat, and assessed as 'Fairly High' conservation value under the CCI scoring system.</p>
<p data-bbox="284 824 566 857">WFD Characterisation</p> <ul data-bbox="284 862 1404 1019" style="list-style-type: none"> • Classified WFD Waterbody – No • SEPA Monitoring Data Available for Watercourse – No • Receiving Downstream Classified WFD Waterbody – Funtack Burn (WB ID 23008) • Overall Ecological Status of Receiving WFD Waterbody – Good Status (2014 Classification) <p data-bbox="284 1023 1220 1057">River Habitat Survey (Survey Codes WC-016-RH-001 and WC-016-RH-002)</p> <ul data-bbox="284 1061 1436 1982" style="list-style-type: none"> • Representative Channel Dimensions: <ul data-bbox="311 1097 1292 1176" style="list-style-type: none"> - WC-016-RH-001: Water Depth: 0.15m Water Width: 3.0m Bankfull Width: 4.0m. - WC-016-RH-002: Water Depth: 0.15m Water Width: 2.5m Bankfull Width: 4.0m. • Habitat Modification Scores (HMS): <ul data-bbox="311 1220 622 1299" style="list-style-type: none"> - WC-016-RH-001: 2611 - WC-016-RH-002: 1696 • Habitat Modification Class (HMC): <ul data-bbox="311 1332 813 1411" style="list-style-type: none"> - WC-016-RH-001: 5 (Severely modified) - WC-016-RH-002: 5 (Severely modified) • Summary: Dalmagarry Burn is a direct tributary of Funtack Burn. WC-016-RH-001 encompasses the A9 crossing whereas WC-016-RH-002 is downstream of the A9 crossing. Both reaches have been historically realigned, with reach WC-016-RH-001 also historically reinforced and embanked in parts. In total, reach WC-016-RH-001 is spanned by 3 bridges which, alongside more extensive channel and bank modifications, contributes to the higher HMS recorded for this reach. Both reaches showed signs of natural recovery with side bars and mid-channel bars creating variation in bed profiles and giving rise to both high and low energy flow types, providing a range of river microhabitats. A range of bed substrates were also recorded across both reaches (cobble, gravel-pebble and sand). Land use is predominantly rough pasture across both survey reaches. Few macrophyte functional groups (indicators of vegetative river habitat diversity) were recorded, but this is expected for a dynamic upland river of this type. • Constraints: The effect of land use on riparian vegetation was apparent, particularly in reach WC-016-RH-001. Tree cover was sparse and associated wooded habitat features that would naturally be associated with a river of this type (i.e. shading, exposed bankside roots and large woody debris) were absent. Reach WC-016-RH-002 runs arrow-straight, with little sign of recovering natural sinuosity that would have been present within the river, prior to its realignment. <p data-bbox="284 1986 1204 2020">Fish Habitat Survey (Survey Codes WC-016-FH-001 and WC-016-FH-002)</p> <ul data-bbox="284 2024 1436 2105" style="list-style-type: none"> • Summary: Both reaches provide a variety of glide, pool and riffle/run habitat (within the context of a minor channel). Spawning habitat was present but more predominant in lower reaches, downstream of the A9. Undercut banks and wooded habitat features in lower reaches locally

improve fish habitat diversity. A 2011 FNLFT electric fishing survey approximately 600m upstream of the existing A9 crossing identified salmon and trout fry and parr (no other species were recorded), with salmon parr recorded in relatively high abundance (17 parr per 100m²). Small numbers of juvenile salmonids and common minnow were also observed during freshwater pearl mussel surveys in this reach (see Annex E). Other lithophilic gravel spawners such as lamprey may be present in low numbers, given habitat suitability, in addition to eurytopic species such as European eel. However species diversity is likely to be low, as is common for upland rivers of this type.

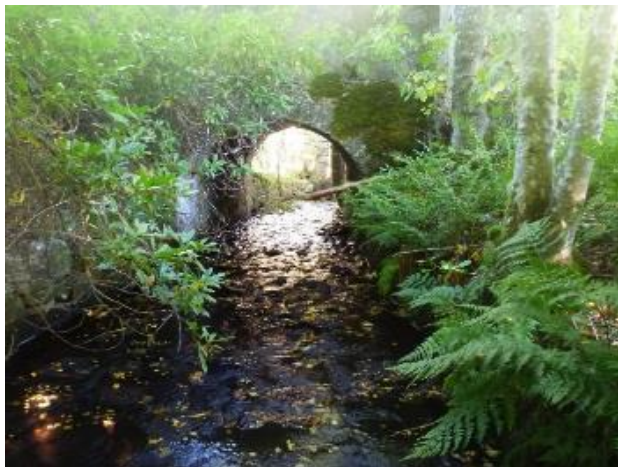
P1030905 - downstream of A9

- WC-011-RH-002: 4 (Significantly Modified)
- Summary: The Allt na Loinne Mòire is a direct tributary of the Moy Burn. WC-011-RH-001 is upstream of the existing A9 crossing whereas WC-011-RH-002 encompasses the A9 crossing. The combination of the A9 itself, channel and bank re-sectioning apparent at survey (there is evidence of historical impounding structures and an associated realignment), and the presence of a railway bridge within the same reach give rise to the different HMS and HMC recorded between the reaches. The Allt na Loinne Mòire was highly dynamic through survey reach WC-011-RH-001, with side bars, point bars and natural berms all present from ongoing lateral channel migration. The system becomes increasingly uniform through the lower survey reach (WC-011-RH-002), as a result of historical modifications. However a range of bed substrates were recorded across both reaches (boulder, cobble, gravel-pebble, sand and silt), with high and low energy flow types and bank profiles (including eroding cliff habitats) providing good habitat diversity throughout. Land use varied between the survey reaches, with extensive moorland (peat bog) associated with reach WC-011-RH-001 and rough pasture extensive throughout reach WC-011-RH-002. Few macrophyte functional groups (indicators of vegetative river habitat diversity) were recorded, but this is expected for a dynamic upland river of this type.

- Summary: Both reaches provide a variety of glide, pool and riffle habitat (within the context of a minor channel). Spawning habitat is present but more predominant in upper reaches- limited in extent by water depth (typically averaging only 0.05m to 0.1m). The size of the channel and water depth observed at survey are likely to limit the salmonid use of this habitat resource, although small numbers of juvenile salmonids were observed within the reach during freshwater pearl mussel surveys (see Annex E). Other lithophilic gravel spawners such as minnow and lamprey may be present in low numbers, given habitat suitability, in addition to eurytopic species such as European eel. However species diversity is likely to be low, as is common for upland rivers of this type.

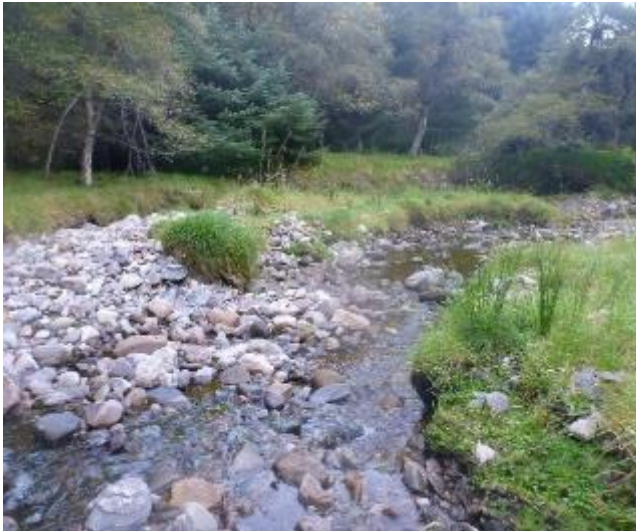
species recorded over three sample points (see Annex C.2). 24 families were represented (the Scottish mean is approximately 25^{xvi}, from a monitoring network comprising over 300 monitoring sites, most of which are located on much larger river systems than the Allt na Slànaich). Of these, 22 were 'scoring' families (NTAXA) - families which contribute to biological metric calculations for water quality.

- Biological metrics are indicative of good habitat diversity and water quality, high flow velocity conditions and low channel sedimentation.
- The CCI scoring system is used to assess the intrinsic conservation importance of the community present. CCI scores of 11.39, 10.00 and 13.33 were recorded from respective sites, which are considered to be communities of 'Fairly High' conservation importance under the system.

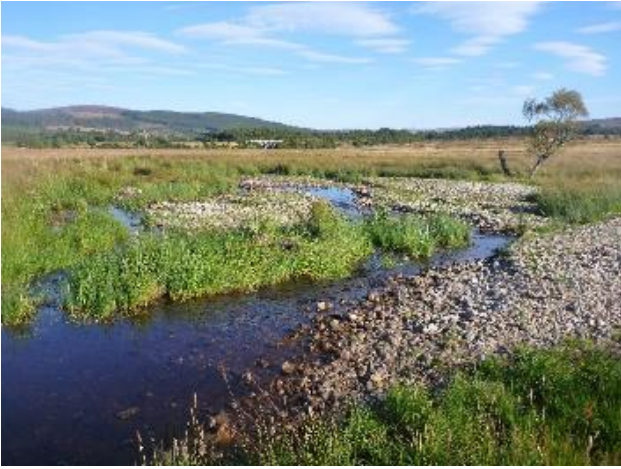
- Biological metrics are indicative of good habitat diversity and water quality, high flow velocity conditions and low channel sedimentation.
- The CCI scoring system is used to assess the intrinsic conservation importance of the community present. CCI scores of 13.13 and 11.79 were recorded from respective sites, which are considered to be communities of 'Fairly High' conservation importance under the scoring system.

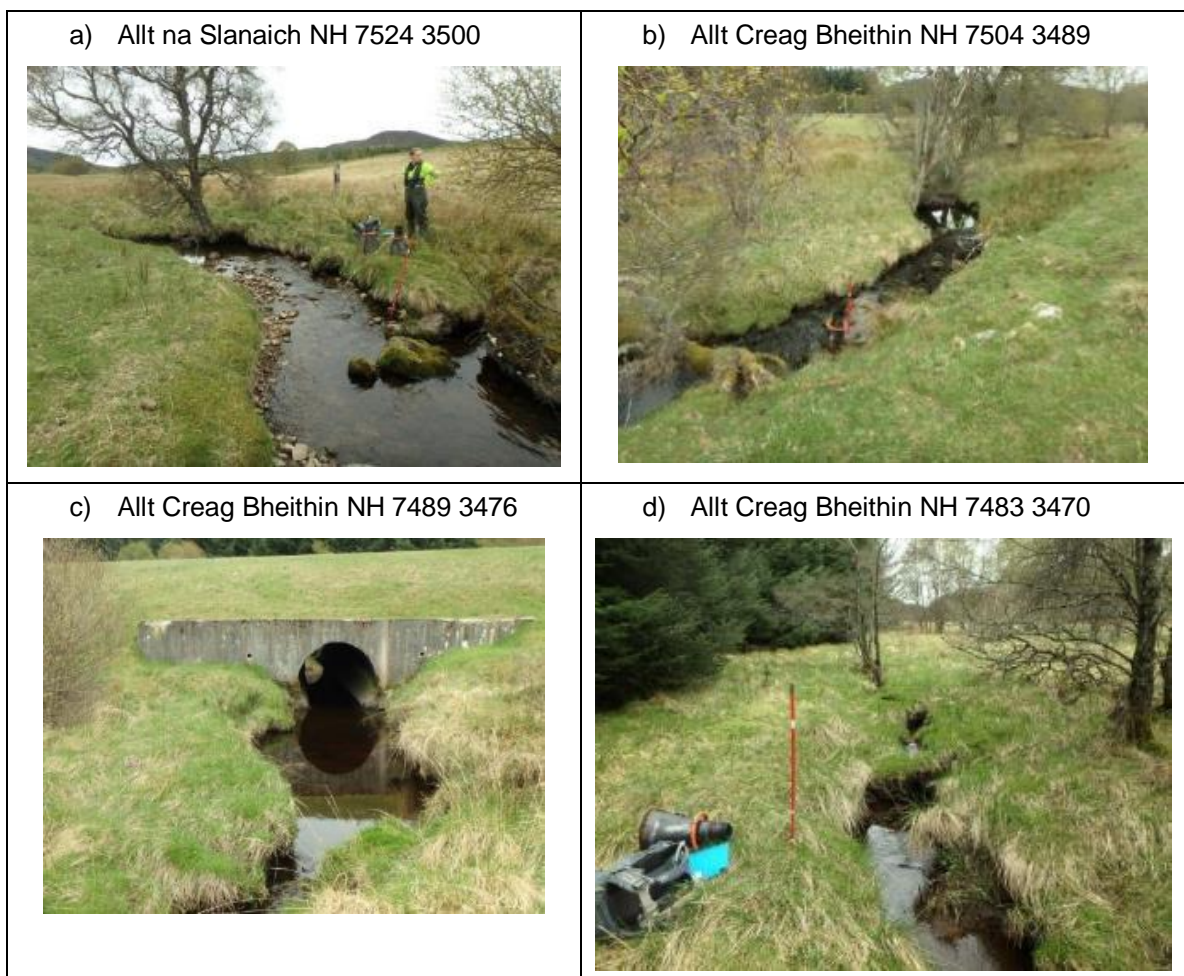
Figure 1: Typical survey reaches, WC-004-PM-001

- E.5.5 Survey sections in this and other streams are listed in Appendix I and details of substrate composition and other physical characteristics in representative 50m transects are provided as Appendix II.

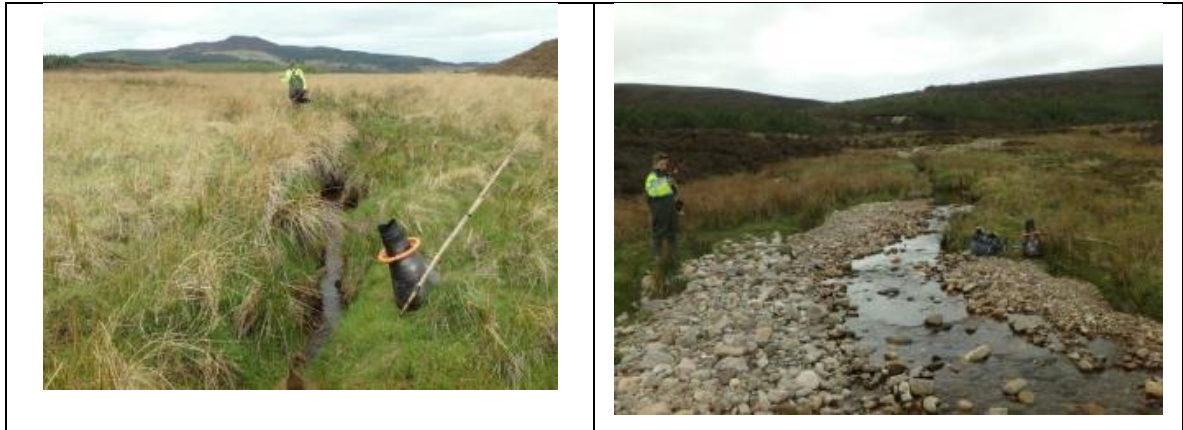
Figure 3: Typical survey reaches, WC-011-PM-001

- E.5.10 The survey commenced at the confluence of Allt na Loinne Moire and Moy Burn, approximately 0.6 km downstream of the A9 road.

- E.5.14 The crossing will be located upstream of the braided reach. Habitats here and in the 100m of channel immediately upstream are characterised by moderate to fast current speeds and unstable substrates of cobble, pebble and boulder (Figure 3d). This habitat is unsuitable for freshwater pearl mussels. No freshwater pearl mussels or dead shells were found in any the survey sections up or downstream of WC-011. Small numbers of host fish were seen in eight of the 13 most downstream survey sections (Appendix I). These included four sections upstream of the barrier between the B9154 and the railway (Appendix I).

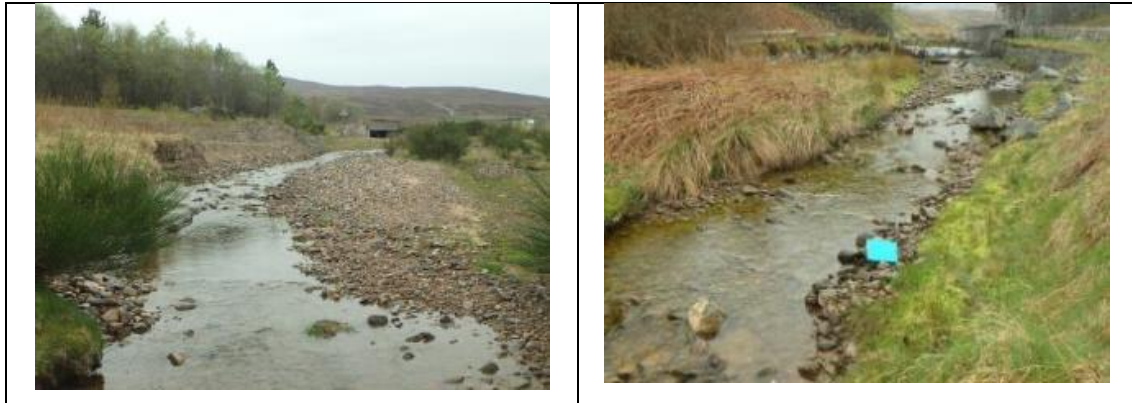
Figure 4: Typical survey reaches, WC-016-PM-001

- E.5.15 The survey commenced downstream of the existing A9 road and the adjacent railway line.
- E.5.16 The two most downstream survey sections are characterised by unstable, angular substrates of cobble and pebble in a broad shallow stream (Figure 4). Wet width is approximately 4m with a bed width of 4.5m. Depth is typically 0.1m. The channel lacks meanders or a defined thalweg and may have been straightened in the past, although this is uncertain. Streambed substrate is clearly very mobile and instream habitat in these sections is consequently entirely unsuitable for freshwater pearl mussels. The wet width of the stream decreases around NH 7895 3208 and from here to the A9 road the stream has a meandering channel with rapid erosion and deposition on the various bends. The mobile substrates of cobble and pebble provide no suitable habitat for freshwater pearl mussels (Figure 4b and c).

- E.5.17 Upstream of the A9 the banks are more stable and there are fewer large depositional features (Figure 4d). The stream is approximately 3.5m wide with typical depths of 0.1 to 0.2m. There is a higher proportion of boulder than in the reaches downstream and a few pockets of coarse sand are present. However, these are not stable and habitat quality remains almost entirely unsuitable. No live or dead freshwater pearl mussels were found in the Dalmagarry Burn. Host fish were seen throughout the survey reaches. Common minnows *Phoxinus phoxinus* were seen in the slower reaches.

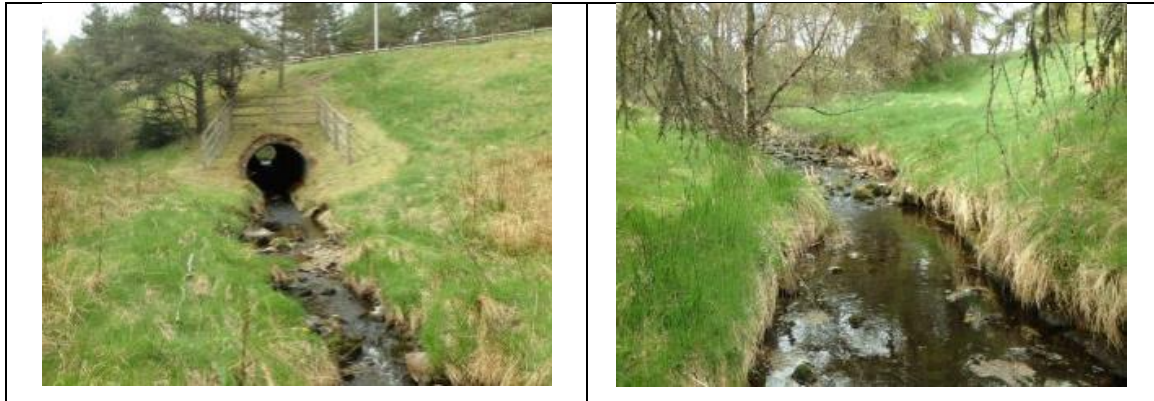
Figure 5: Typical survey reaches, WC-019-PM-001

- E.5.18 The survey extended from the River Findhorn confluence upstream to the minor road bridge at NH 7928 3042.
- E.5.19 The first 150m of the Allt Dubhag upstream of the River Findhorn is 1.5m wide with an average depth of approximately 0.15m. Gradient is moderate. Patches of potentially suitable habitat for pearl mussels are scattered throughout this reach in the form of coarse sand stabilised by large cobbles and boulders (Figure 5a). A little bank erosion is evident on the outside of bends but the channel is mainly stable. From NH 7949 3062 to the A9 road the gradient increases and the streambed is less stable. There are many exposed side and point bars along the meandering channel and much of the streambed appears unstable. The stream is heavily shaded and many trees have fallen into or collapsed over the channel making access difficult. Substrate is primarily cobble and pebble with some sand and gravel. Most of the instream habitat is too unstable to support mussels although a few isolated patches of potentially suitable habitat were noted (Appendix I). The stream flows beneath the A9 via a concrete culvert (Figure 5c).

- E.5.20 Upstream of the A9 the gradient is moderate with mixed substrates and flow types (Figure 5d). Wet width is typically around 1.5 to 2.0m. The banks are partly wooded and mainly stable. Patches of sub-optimal mussel habitat are widespread but sparse and overall habitat quality was classified as poor. No live mussels or dead shells were found in the survey reaches of Allt Dubhag. Host fish were seen throughout.

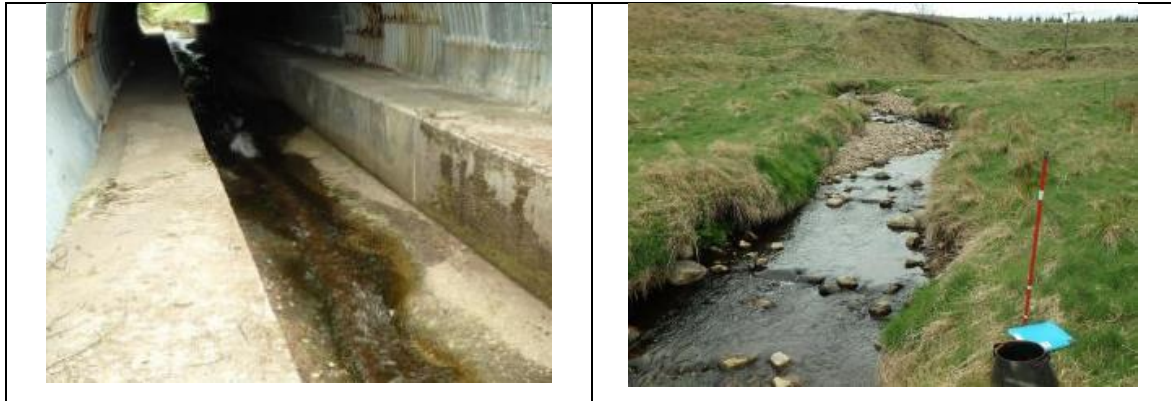
Figure 6: Typical survey reaches, WC-022-PM-001

- E.5.21 The Proposed Scheme crossing is located on the Allt na Frithe adjacent to the existing A9 crossing. This is some 150m upstream of the confluence of Allt na Frithe with the River Findhorn. Therefore the survey commenced in the River Findhorn downstream of the confluence.
