Cartsburn Automated Self-Cleaning Trash Screen Debris Removal Impact on Local Flood Risk Benefits

Inverclyde

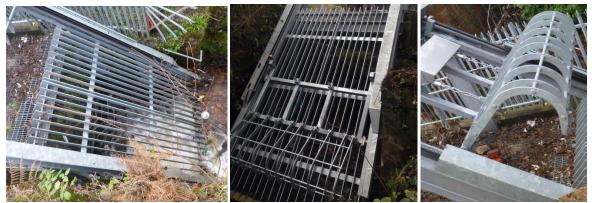
Figure 3. Automated self-cleaning trash screen at Crescent Street culvert inlet.

In January 2015 the automated self-cleaning trash screen, designed by GJ Edwards Consulting Engineers Ltd in conjunction with Inverclyde Council and Transport Scotland, was installed at the Carts Burn culvert inlet at Crescent Street (shown in Figure 3). The grate is designed to current best standards, with screen bar spacing of 150mm and an inclined screen angle (Wallerstein et al. 2013). The trash screen extends 2m across and 3m high, over the entire existing culvert inlet.

The trash screen has been built with a forward/upstream facing arm than extends over the trash screen to collect detained debris. The debris collection arm is lowered and raised along two electrically powered screw mechanisms located on either side of the screen, negating the requirement for hydraulics. Using screw mechanisms to raise the debris collect arm allows significant weight to be lifted up and over the trash screen without risk of overloading. The screen is operated remotely, with a manual over-ride located at the physical trash screen. Cleaning can be set to occur periodically, as considered necessary prior to major rainfall events, or regularly to maintain a clear trash screen. The Carts Burn automated self-cleaning trash screen was set to self-clean twice per day.

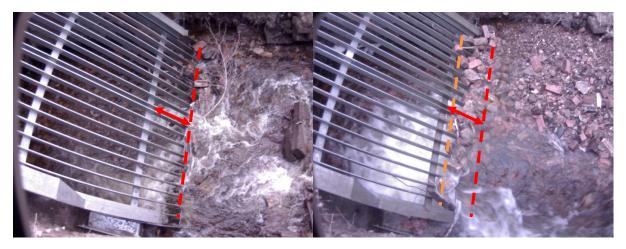
Figure 6. January 2015 (commencement of the study) and February 2016 (cessation of the study) photographs illustrating bed level change.

Over the 12 month monitoring period, 80% for the recorded flow depths were between 0.05 -0.20m, illustrating the base flow water depth for this reach of the Carts Burn. The base flow level illustrated in April-May 2015 was consistently 0.05-0.06m in depth. Minimal rainfall occurred during this period. The second extended low rainfall period occurred in September 2015 and then for a short period in January 2016. The base flow level illustrated during these latter periods is 0.08-0.1m. This is a key finding for the ongoing management of this trash screen. Over the 8 months (between April 2015-January 2016) the morphological change in the Carts Burn at this location was approximately 0.5m (build-up of rocky debris in front of the trash screen and within the culvert) resulting in a base flow water level increase of 0.03m (in the culvert). This finding was confirmed through camera footage, illustrated in Figure 6.

While this is a base flow increase is small, 0.03m, it is occurring due to geomorphological change in the channel and this will result in a significant loss of conveyance capacity over time. The cause of the channel geometry change is clearly visible, resultant from rocky debris deposition in front of the trash screen grate. The Carts Burn is a fast flowing watercourse and the large rock/boulder conveyance capacity of this water is therefore high. Thus rocky debris from the influencing reach of the Carts Burn (close to the automated trash screen) is being conveyed to the downstream obstruction point (the trash screen itself). Furthermore, the conversion of the watercourse from an open waterway to a culvert at Crescent Street has resulted in a significant watercourse bed slope change. The Carts Burn has a steep bed slope, including numerous small cascades. The Crescent Street culvert links this steep watercourse to the River Clyde and has a shallow grade. Due to this change the watercourse bed slope the entrance to this culvert would naturally act as a rocky debris deposition zone. However, the installation of the automated self-cleaning trash screen at this point has exacerbated this rocky deposition, as seen by the build-up of rocky debris along the front of the grate in Figure 11. Though continuous monitoring of the water depth and trash screen by remote sensors and camera equipment, the importance of rocky debris management on the Carts Burn has been clearly illustrated. While the automated trash screen does remove some large rocky debris from the screen (35 boulders/bricks over 3 months) the self-cleaning mechanism is not designed for rocky debris removal. It is recommended that future placement of trash screens take rocky debris deposition into consideration and provide either: i) a rocky debris deposition zone upstream from the trash screen, in an area that is easily accessible for clearing; ii) place the trash screen on a watercourse reach with a stable and continuous stream bed slope; or, allowing sediments to pass under the screen.

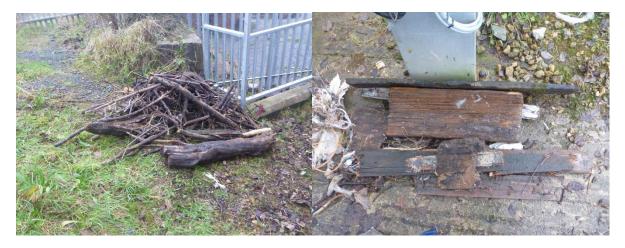
1) Woody debris

2) Timber planks

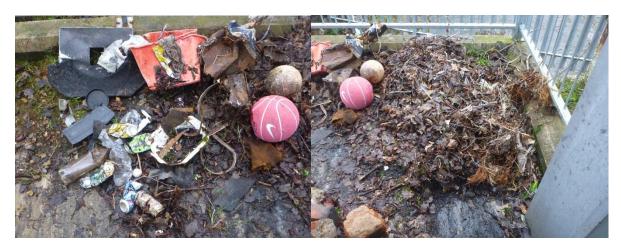
- 3) Cans, bottles, extraneous metal, balls
- 4) Leafy detritus

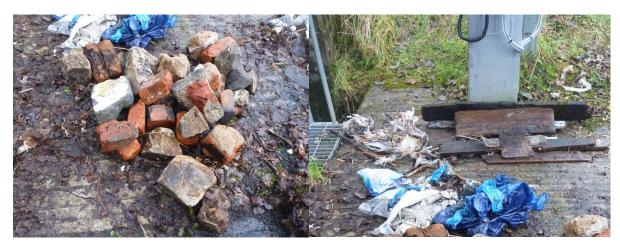
5) Boulders/bricks

6) Plastic bags
