## 15 Cultural Heritage

15.1.1 This chapter represents the DMRB Stage 3 cultural heritage detailed assessment for the proposed scheme. The chapter considers the impacts of the proposed scheme on cultural heritage under the three sub-topics of archaeological remains, historic buildings and the historic landscape. Additional information to support this chapter is presented in the following appendices:

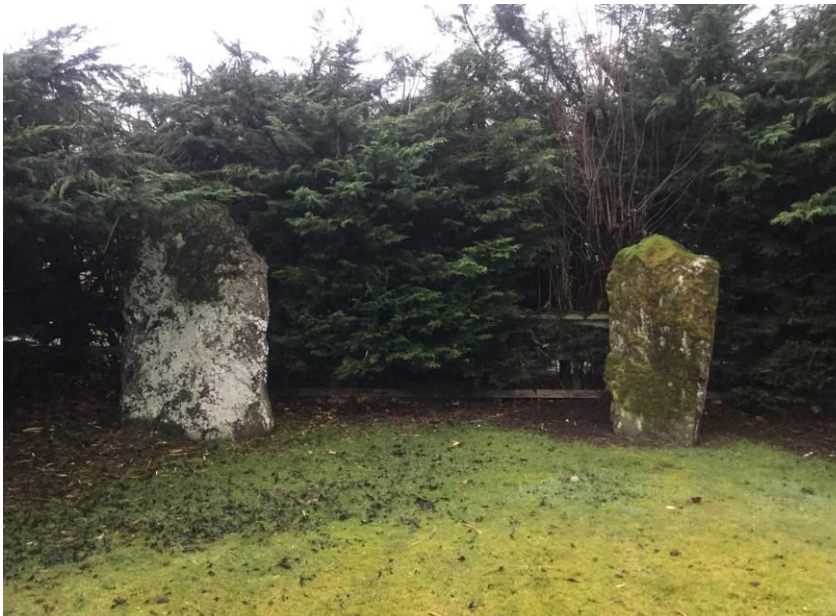
**Photograph 15.2: Clachan More standing stones A9 (Asset 207)**

- 15.3.10 Clachan More (Asset 207) comprises two standing stones of likely Neolithic or Bronze Age date. They are situated on level ground at around 60m AOD, and are aligned east-west. There is evidence that the western stone has been re-set and early 20<sup>th</sup> century descriptions and sketches show the stones on a north-south alignment, and could have originally formed part of a larger alignment, or been part of a stone circle. The standing stones are identified as being of national importance as they have the potential to make a significant contribution to our understanding of the past, in particular the design and development of prehistoric burial and ritual monuments. In addition, there is the potential for the survival of archaeological remains beneath and around the standing stones.

- 15.3.11 As outlined above, the standing stones may have formed part of a larger alignment or stone circle, and given their location in a valley bottom, would have been intended to be a focal point or marker, an attribute common to other prehistoric monuments within the study area. The stones today are located within an enclosed garden, and a high conifer hedge and surrounding dwelling obscures them from any previously intervisible monuments (see Photograph 15.2), and due to this intervisibility with other contemporary monuments are not considered to form part of their overall value.

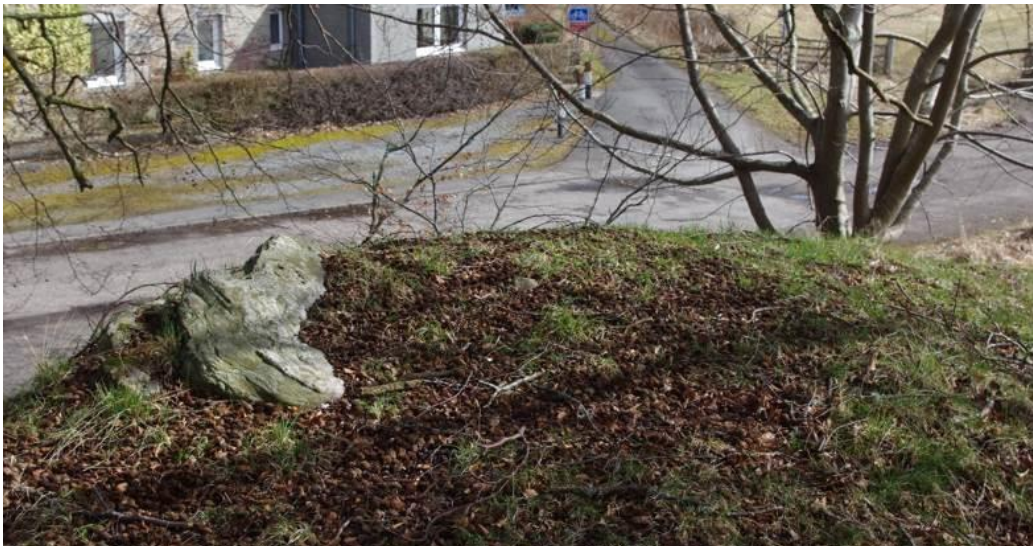
- 15.3.15 The location of the cist on the top of the mound, exploiting a prominent natural feature on the valley floor, is suggestive of the creation of a focal point, or visible marker, within the surrounding landscape. While the natural mound itself would have been a prominent feature at the base of the river valley, its use as a place for human burial in proximity to other later prehistoric sites may indicate a shift towards the role of prehistoric funerary monuments acting as local land markers (Parker-Pearson, 2009). The palaeoenvironmental evidence from the satellite burial excavated in 2007 suggests that it was located in wider managed landscape, with samples yielding evidence of controlled vegetation and cereal production as well as rough ground and native trees (CFA, 2008), although the samples could not be securely dated to the prehistoric period they provide a suggestion of the landscape while the second possible grave was open.

**Photograph 15.3: Cist slabs on the top of Kindallachan Cairn (Asset 221)**

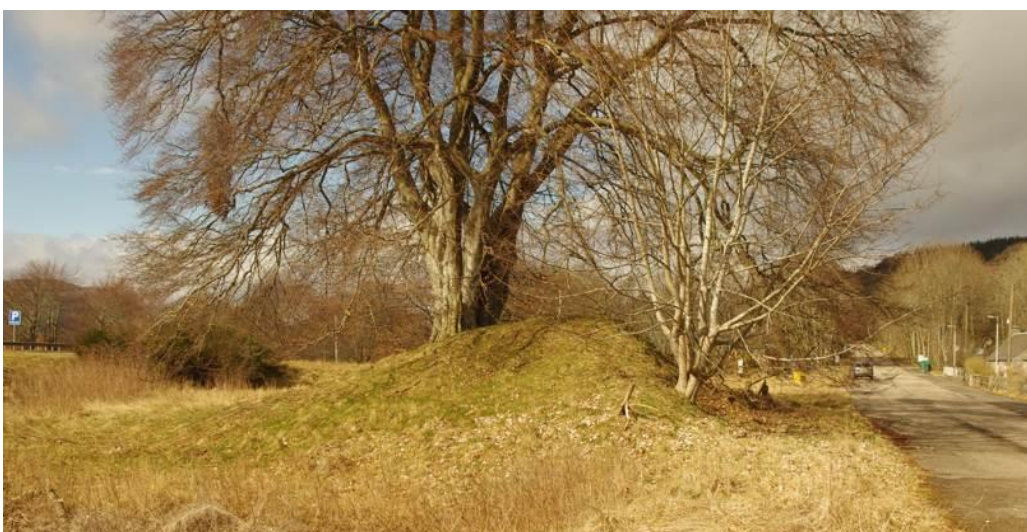
**Photograph 15.4: View of Kindallachan Cairn looking north-west (Asset 221)**

- 15.3.13 Kindallachan Cairn (Asset 221) comprises the remains of a mound of natural origin, that lies in a triangular area between the existing A9 and an unclassified road. The remains of a cist were found within the mound during excavations in the 1950s and a possible satellite burial was uncovered in 2007 (see Photograph 15.3), although very few artefacts were recovered from either feature. The triangular shape of the scheduled area reflects the nearby roads, and the mound was cut into during the realignment of the old A9 in the 1950s.

- 15.3.19 The cairn is located within an area of rough overgrown vegetation with the existing A9 to the west and an un-named village road to the east (see Photograph 15.4). Towards the River Tay (to the west) the land is relatively flat but it rises steeply to the east, beyond a row of stone cottages to the south of the village of Kindallachan, into established woodland. A drainage ditch runs adjacent to the A9, to the west of the cairn, and there is a mature beech tree growing on the cairn. Views to the north towards Kindallachan Standing Stone are filtered by woodland planting to the south of Croft Croy, although there is still an element of intervisibility between the two monuments.

- 15.4.6 In addition to the loss of the cairn itself, there would be potential impacts on the wider prehistoric ritual landscape of Strath Tay. The cairn is part of the setting of Kindallachan Standing Stone (Asset 225), and while the cairn cannot be seen from the standing stone due to intervening woodland at Croft Croy, it is likely that the monuments would have been intervisible in the past. In addition, the cairn is contemporary with a number of other burial cairns of likely Bronze Age date such as the examples at Dunfallandy and Sithean as discussed in 15.3.14. The removal of the cairn would therefore result in a reduction in the way the prehistoric ritual landscape of Strath Tay is experienced and understood.

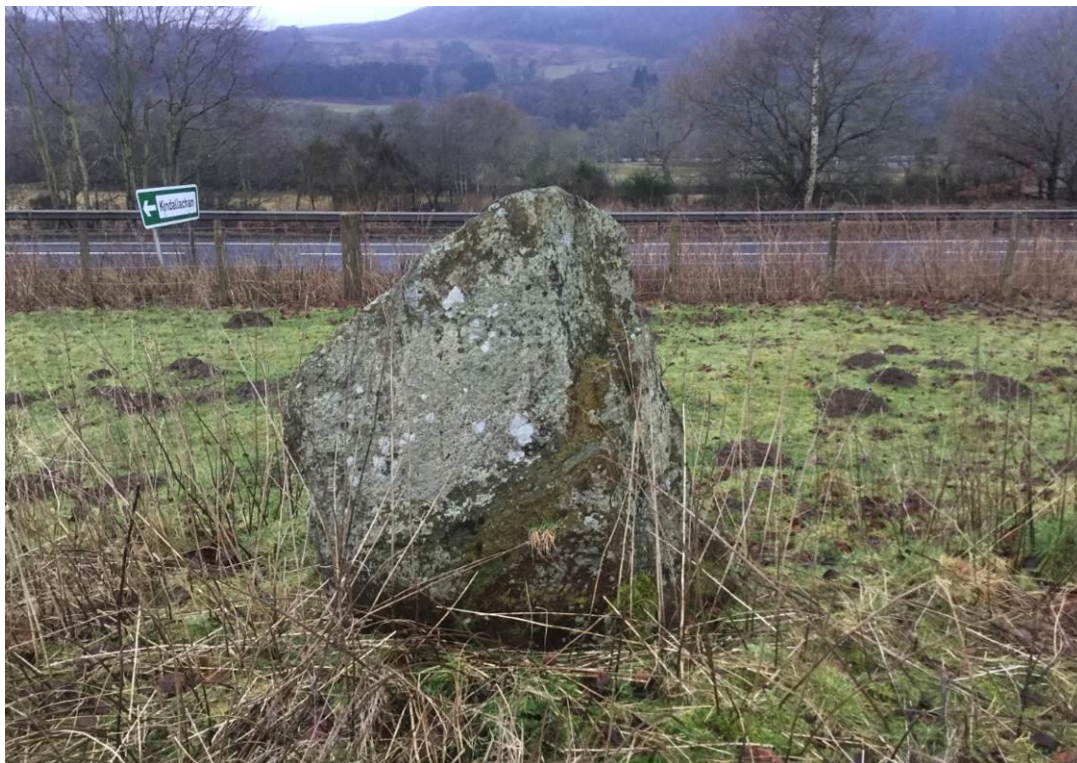
**Photograph 15.5: Kindallachan Standing Stone looking west to the existing A9 (Asset 225)**

- 15.3.21 Known locally as the 'Druid's Stone', Kindallachan Standing Stone (Asset 225) is squat and almost diamond in profile. It lies on a small mound that has been created by the plough avoiding the monument over the years. It lies within an agricultural field just east of the existing A9 at about 60m AOD, and stands at approximately 1m tall (see Photograph 15.5).

- 15.5.9 To mitigate any potential for accidental damage to Kindallachan Standing Stone (Asset 225; a Scheduled Monument) during construction, the asset will be protected as required following discussion

between HES and Transport Scotland's appointed contractor and will be clearly demarcated with protective fencing and appropriate signage. In addition, prior to works commencing a photographic survey of the standing stone and scheduled area will be undertaken and again on completion of the works to ensure that the condition of the scheduled area is returned to its previous state (**Mitigation Item P03-CH7**). These measures would be agreed in advance with HES and will require Scheduled Monument Consent

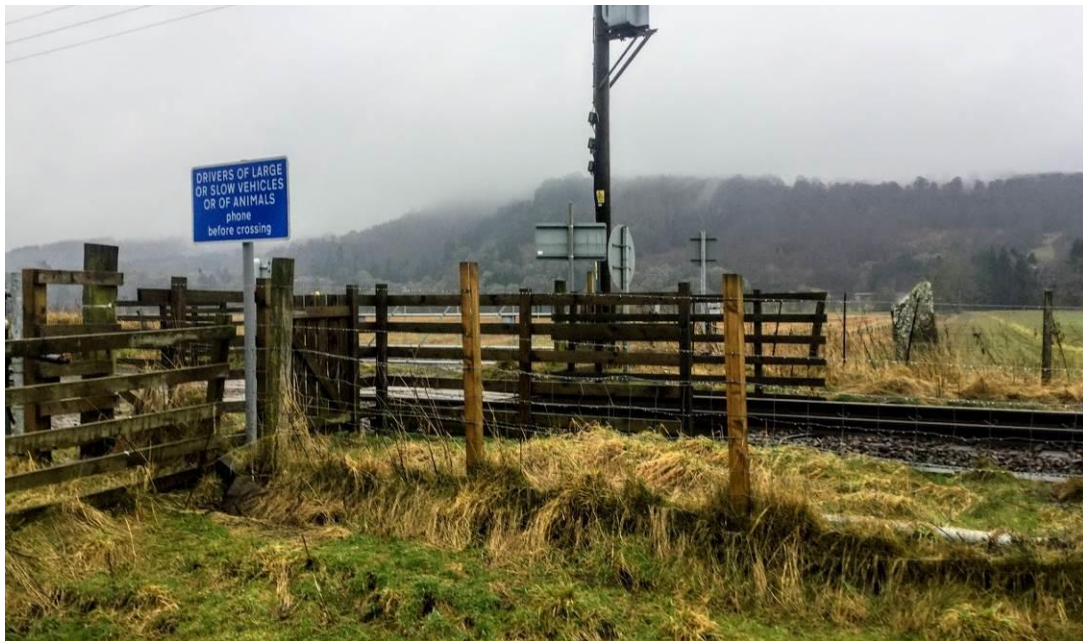
**Photograph 15.6: Clach Glas standing stone (Asset 236) (to the right of the photograph) looking east over the Highland Main Line railway**

- 15.3.27 This single standing stone (Asset 236) is approximately 2m high, lying around 130m west of Westhaugh of Tulliemet. Of note are two cup marks on its east face. It is thought to date to the Neolithic or Bronze Age and relate to ritual activity from this time.

- 15.3.29 The standing stone is located next to a level crossing over the Highland Main Line railway, and views to the north and west are dominated by the railway, the existing A9 and modern farms and dwellings (see Photograph 15.6). To the south and west the stone retains its relationship with the open landscape, and river associated with Strath Tay.

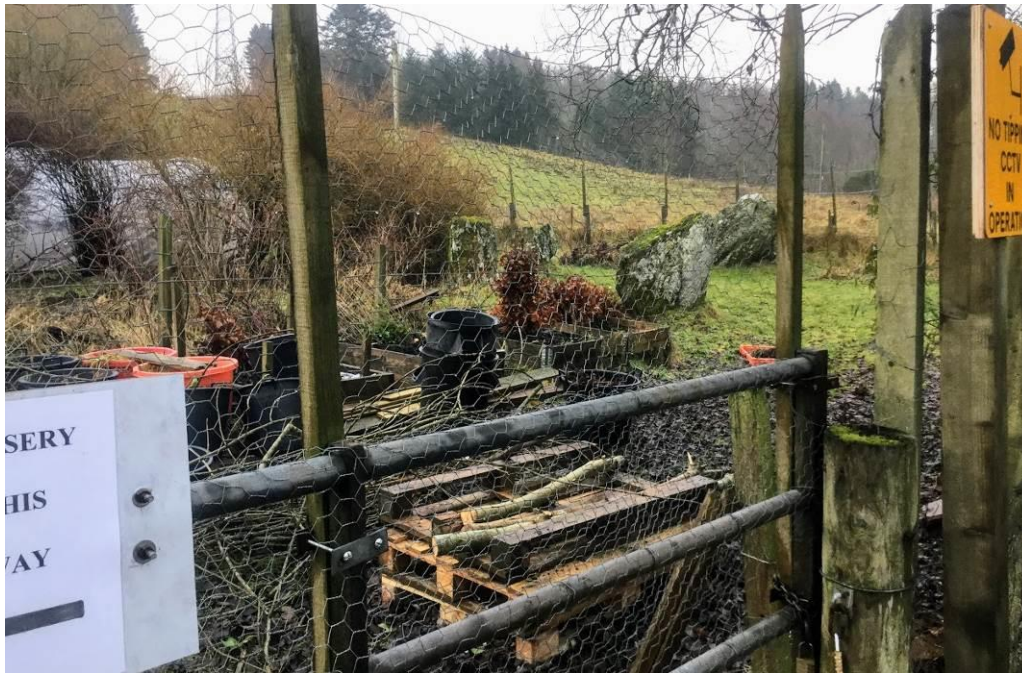
**Photograph 15.7: Tynreich Cottages stone circle (Asset 756) within garden centre compound**

- 15.3.31 These stone circle remains (Asset 765) date to the third or second millennium BC, that is visible as a slightly elliptical setting of six upright stones. It is located in the grounds of a garden centre on a terrace to the east of the River Tummel, at around 80m AOD.

- 15.3.32 Today, the stone circle is located in the south-western corner of a fenced rectangular plot of land currently occupied by a garden centre (see Photograph 15.7). The existing A9 is located approximately 32m to the west of the monument, and forms a prominent component of its setting. Views to the west are restricted by forestry adjacent to the River Tummel with only the peaks of the hills beyond visible above the treeline. While the setting does not enhance our appreciation of the asset and creates difficulties in understanding its significance within the wider ritual landscape, it is likely that its position close to the Tummel and the hills beyond may have played an important role in its original siting.

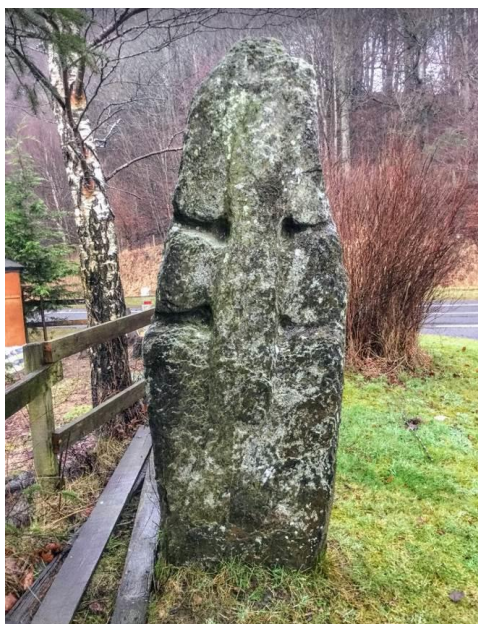
**Photograph 15.8: Westhaugh of Tulliemet cross slab (Asset 235), viewed from the west looking towards the existing A9**

- 15.3.34 This plain cross slab (Asset 235) (with the cross repeated on both sides of the stone), dates to the early medieval period and provides evidence of the spread of Christianity in Scotland from the 5<sup>th</sup> century AD onwards. The stone is approximately 1.8m in height.
- 15.3.35 A house and gardens, as well as the existing A9, form the setting of the cross slab today, and it is considered likely that it no longer occupies its original, intended location (see Photograph 15.8). Despite this, taking into account its designation as a Scheduled Monument and its potential to contribute to the research theme of exploring the immediate context of this type of monument to better understand their possible ritual associations through physical and material remains (ScARF, 2012b), it has been assessed to be of high value.

180m SE of (Asset 235, Figure 15.1d; a Scheduled Monument). While the footprint of the proposed scheme would not impact on the asset, given the proximity of it to the proposed scheme there is the possibility of accidental damage to it as a result of construction activities. Scheduled Monument Consent may be required for these works.

- 15.5.10 To mitigate any potential for accidental damage to Westhaugh of Tulliemet, cross slab 180m SE of (Asset 235; a Scheduled Monument) during construction, the asset will be supported as required following discussion between HES and Transport Scotland's appointed contractor and will be clearly demarcated with protective fencing and appropriate signage. The proposed fenced area will be confirmed with HES prior to the erection of any protective fencing and will be located outwith the scheduled area. In addition, prior to works commencing a photographic survey of the standing stone and scheduled area will be undertaken and again on completion of the works to ensure that the condition of the scheduled area is returned to its previous state (**Mitigation Item P03-CH7**). These works may require Scheduled Monument Consent.

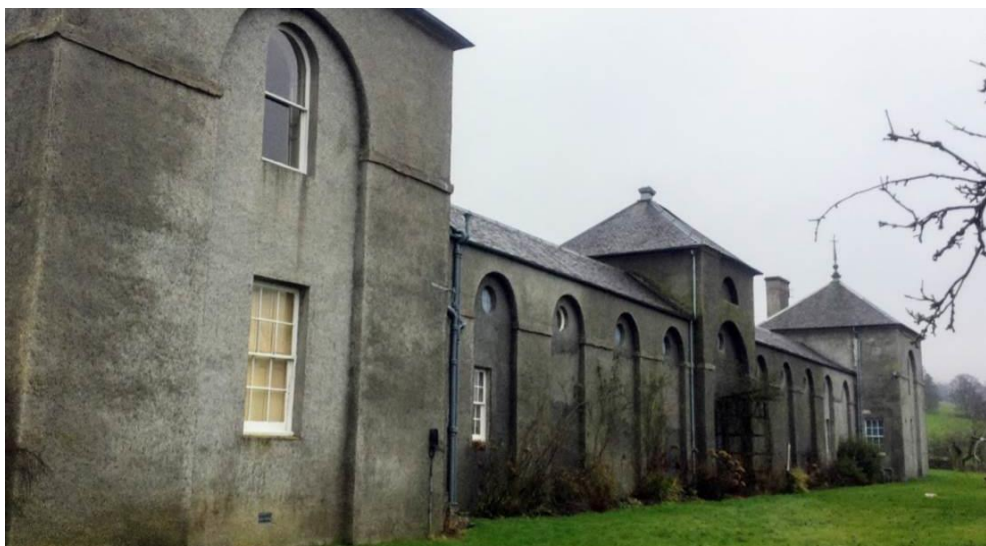
#### **Photograph 15.9: Rotmell Farm (Asset 200)**

- 15.3.48 Rotmell Farm (Asset 200), a Category B Listed Building, is a high status farmstead designed in a polite classical style (see Photograph 15.9). The farm is located on a plateau on the 120m contour overlooking the River Tay floodplain, surrounded by large enclosed rectilinear fields, within sight of the head dyke which separates improved land from rough grazing and woodland on the upper slopes of Deuchary Hill. Its upland location, high above the River Tay, suggests it to have primarily served as a livestock farm.

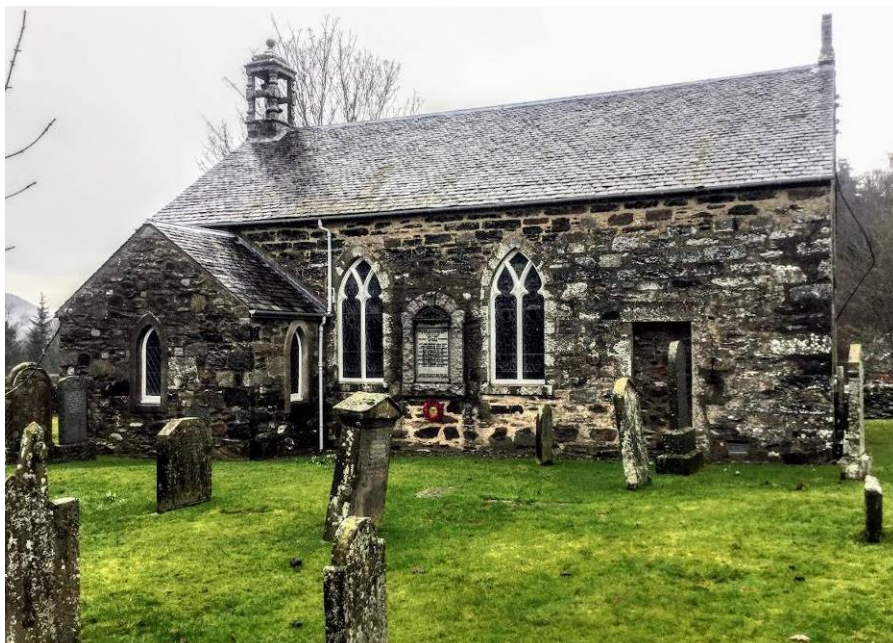
**Photograph 15.10: Dowally Church (Asset 208)**

- 15.3.53 Dowally Church (Asset 208) (also known as St. Anne's Church), is a Category B Listed Building, that was built in 1818. It comprises a T-plan church designed in a simple Gothic style, that replaced an earlier church dating from the 16<sup>th</sup> century (see Photograph 15.10). The location of the church with a small sub-circular walled churchyard, surrounded by historic gravestones, contributes to the understanding and appreciation of this as a historic church site.

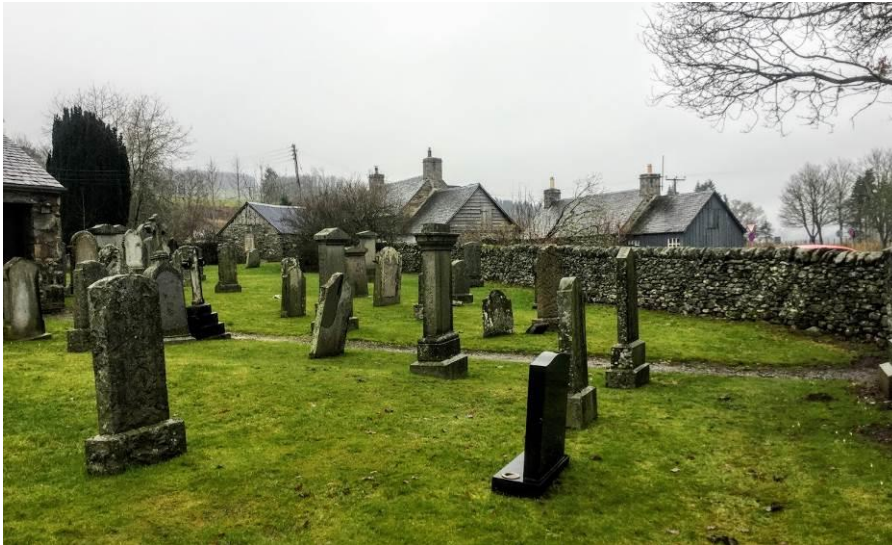
**Photograph 15.11: View from Dowally Church towards Dowally Village**

- 15.3.55 The church forms a group with the historic settlement of Dowally which is located directly to the south (see Photograph 15.11). Comprising a small group of cottages strung along the banks of the Dowally Burn, the church contributes to the understanding of this as an historic settlement.

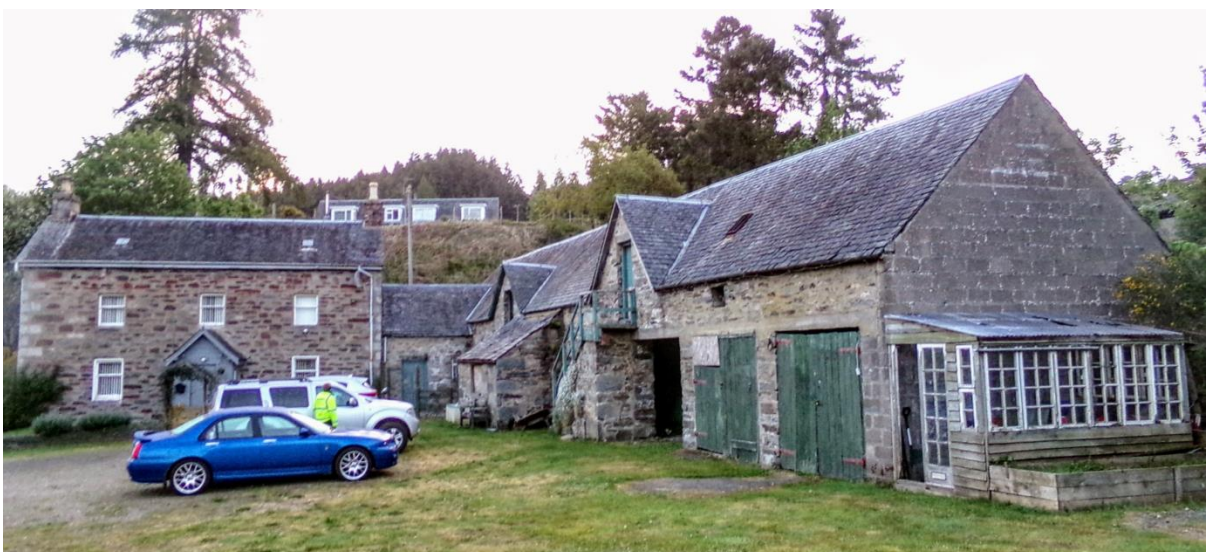
**Photograph 15.12: Guay Farmhouse (Asset 216) viewed from the southbound carriageway of the A9**

- 15.3.57 Guay Farmhouse (Asset 216), a Category B Listed Building dating to the first half of the 19<sup>th</sup> century. The building is L-shaped in plan, set within a small farmyard and comprising a two-storey house (the Range) connected to a single and two-storey steading (the Wing). Both the Range and Wing are listed as a single unit within this designation. There are a number of recent additions to the Wing, including a block-constructed southern gable wall and a timber lean-to.

- 15.3.58 The building is located in a rural setting, immediately to the east of the existing A9 and the Highland Main Line railway, and at the western edge of the small settlement of Guay. The building has had a roadside location since it was built, although the scale of the road has changed markedly over time. The building's cultural significance and special and architectural interest is derived from its remaining original built fabric, external appearance and the development of its historic context and the relationship it retains with its setting.

- 15.3.59 The farmhouse was built around 1835 as a roadside inn, and the original courtyard type arrangement of buildings of the inn complex (since removed by the existing A9 and Highland Main Line railway) was positioned so that the line of General Wade's Military Road (constructed in the 1740s) passed through the central yard of the inn. The building's original function as an inn has been deduced from

and Vibration, paragraphs 17.4.4 - 17.4.8) and interrupt clear views of the River Tay floodplain and the hills to the west resulting in visual intrusion in the setting of the asset. In the absence of mitigation there is also the potential for accidental damage to occur to the farmhouse as a result of construction activities.

- 15.5.14 A Level 2 building record (Historic England, 2016) will be undertaken of Guay Farmhouse prior to construction to record the asset in its current condition. A Level 2 record comprises a drawn record, a detailed measured plan, drawn elevations of areas to be removed/impacted by the alterations, and a photographic and written record (**Mitigation Item P03-CH9**).

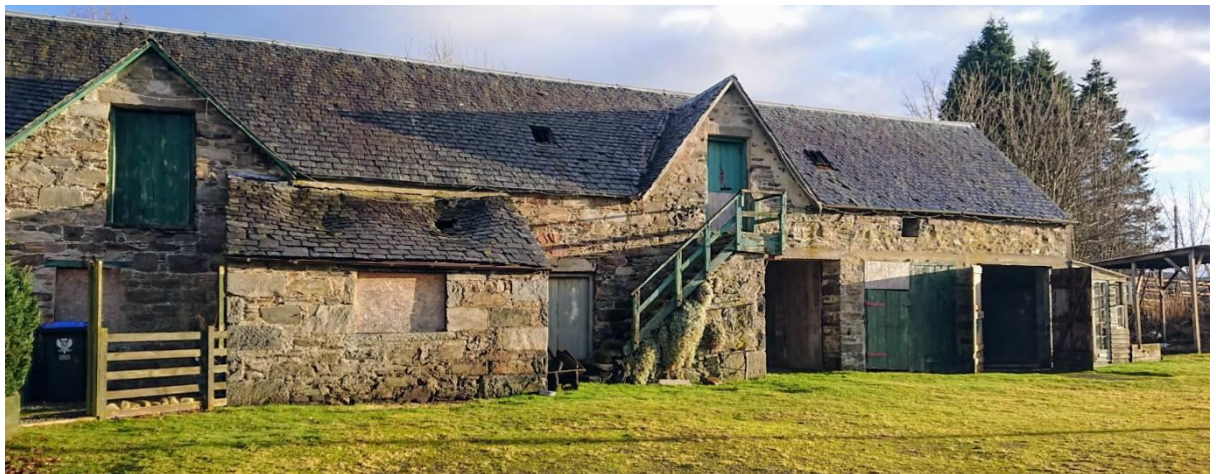
- 15.3.61 Stone is the principal construction material of Scotland's pre-1919 building stock, and at the farmhouse the local building stone used in roughly-hewn blocks of various sizes has been used in the construction of the walls of the Wing (see Photograph 15.13). The greyish stone structure is covered by a moderately pitched stone slate roof supported by wooden trusses. The Wing is presumed to have originally been symmetrical in plan, i.e. there would have been three intersecting roof gables, with the central one being slightly taller than the symmetrically placed side ones. The Wing connects to the Range via a single-storey passage, and in terms of construction materials the passage has the same appearance as the Wing.

**Photograph 15.13: The Wing of Guay Farmhouse viewed from the north**

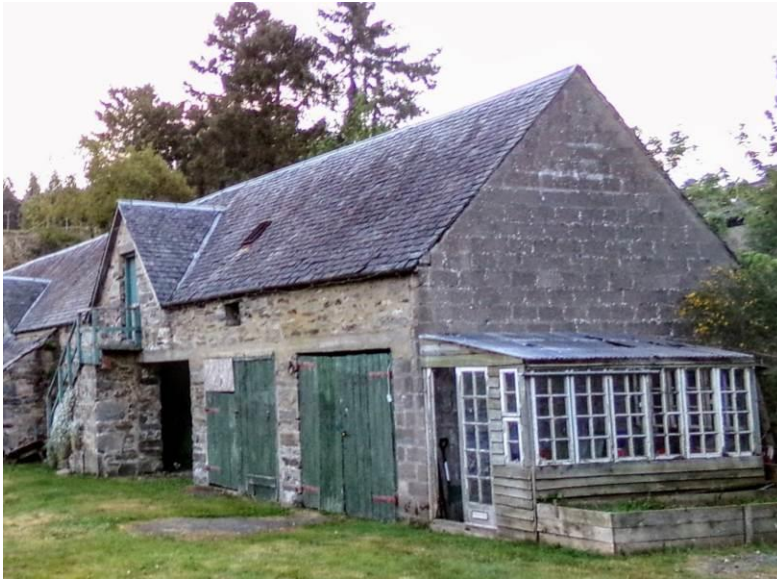
- 15.3.62 The southern end of the Wing has been rebuilt in modern concrete block-work, and it is a reasonable inference to associate this work with the construction of the A9 in the 1970s which resulted in the previous shortening of the Wing (see Photograph 15.14). Despite the alterations of the southern end of the Wing and the addition of larger doorways (presumably to accommodate modern farming machinery), it is still possible to read and understand the originally-intended relationship between the Range and the Wing as that of the farmer's residence and an ancillary agricultural building.

**Photograph 15.14: Modern concrete block-work and lean-to, southern gable end of Guay Farmhouse Wing**

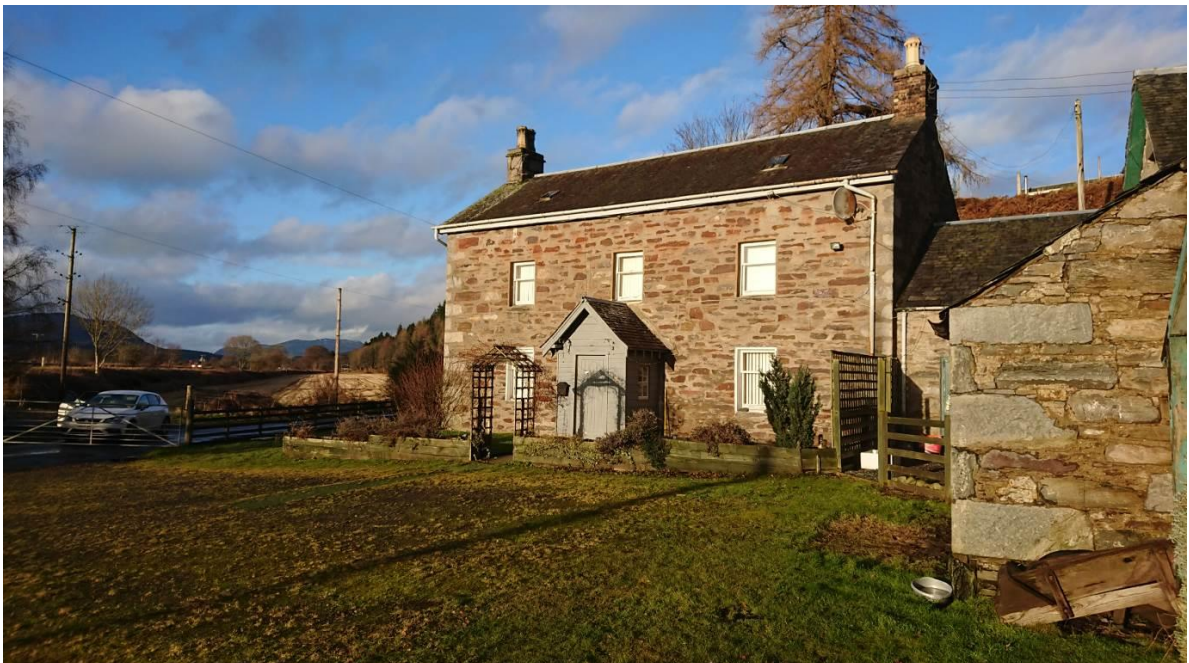
- 15.3.63 The Range, conversely, is constructed from more uniformly-sized and shaped reddish sandstone blocks that are coursed more regularly than the Wing. The symmetrical façade of the Range with its sash-windows can be interpreted as a vernacular take on the polite Georgian architecture in fashion in the early part of the 19<sup>th</sup> century (see Photograph 15.15). It is possible that the Range and the Wing could have been constructed at different times, given the differences between the masonry and style of their construction.

**Photograph 15.15: The Range of Guay Farmhouse viewed from the west**

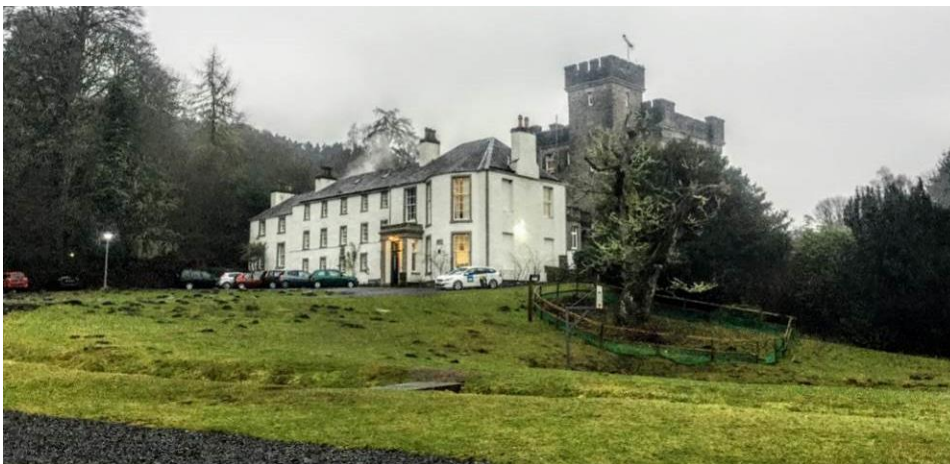
**Photograph 15.16: Dalguise House (Asset 746)**

- 15.3.66 Dalguise House (Asset 746) was originally built in 1753 as three-storey, 4-windowed country residence (see Photograph 15.16). Additional extensions were made to the property in the mid-19<sup>th</sup> century. The building is located within an area of managed woodland and its associated walled and formal terraced garden and stables to the south, and long avenue from Charleston leading northwards through the grounds to the house form components of its setting. It has historic associations with the author Beatrix Potter (known to have spent her summer holidays here), which further enhances the building's heritage interest.
- 15.3.67 Taking into account its designation as a Category B Listed Building and its historic association with Beatrix Potter, the building has been assessed to be of medium value.

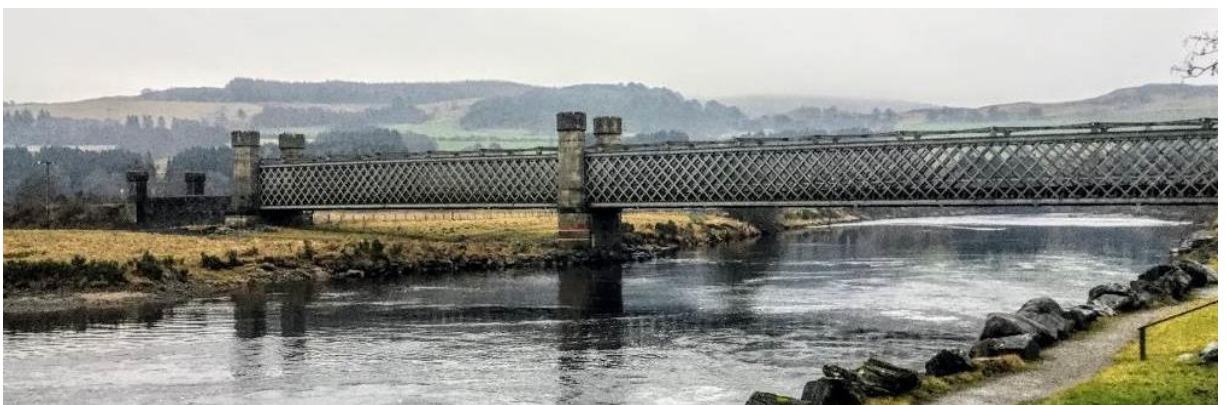
- 15.3.68 Designed by the engineer Joseph Mitchell in 1861-2, the Dalguise Railway Viaduct (Asset 747) is a Category A Listed Building. It is a monumental structure with two wrought-iron lattice-girder spans of 64m and 43m respectively supported on a masonry pier and abutments which are carried up to form castellated terminals (see Photograph 15.17). This viaduct was designed to carry the Inverness and Perth Junction Railway across the River Tay and opened on 9 September 1863.
- 15.3.69 Given the designation of the bridge as a Category A Listed Building, it has been assessed to be of high value.

**Photograph 15.17: Dalguise Railway Viaduct Over River Tay (Asset 747)**

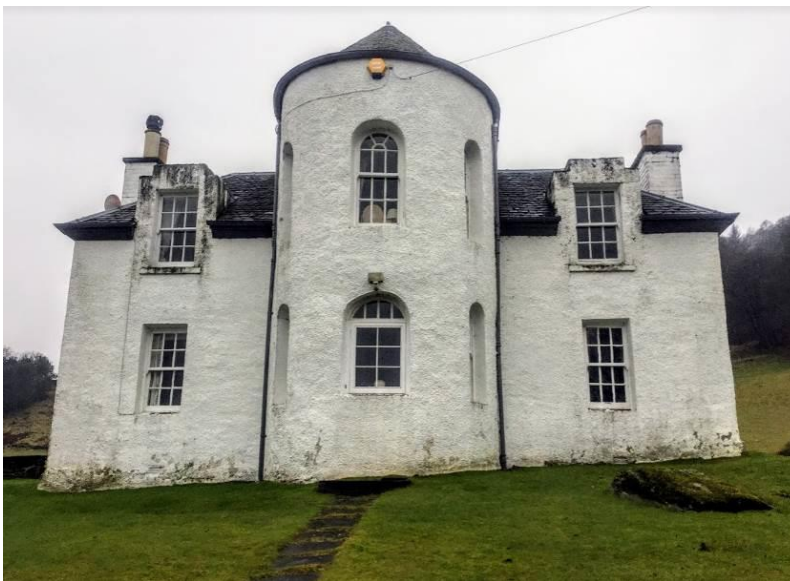
**Photograph 15.18: Upper Kinnaird (Asset 749)**

- 15.3.70 Upper Kinnaird (Asset 749) is a good example of an early 19<sup>th</sup> century bow-fronted centre house, dating from the early 19<sup>th</sup> century (see Photograph 15.18). The building is located on a spur on the lower slopes of Creag na Larach, and it has clear views to the east and south-east, including views of the existing A9, over to the hills of the Forest of Clunie. Views to the south, west and north are restricted by topography. Some screening in close proximity to the eastern elevation is provided by mature trees and garden vegetation, however the A9 is partially visible through these. The wider setting of the asset comprises the River Tay and the hills of the Forest of Clunie that contribute to the heritage value of the asset.

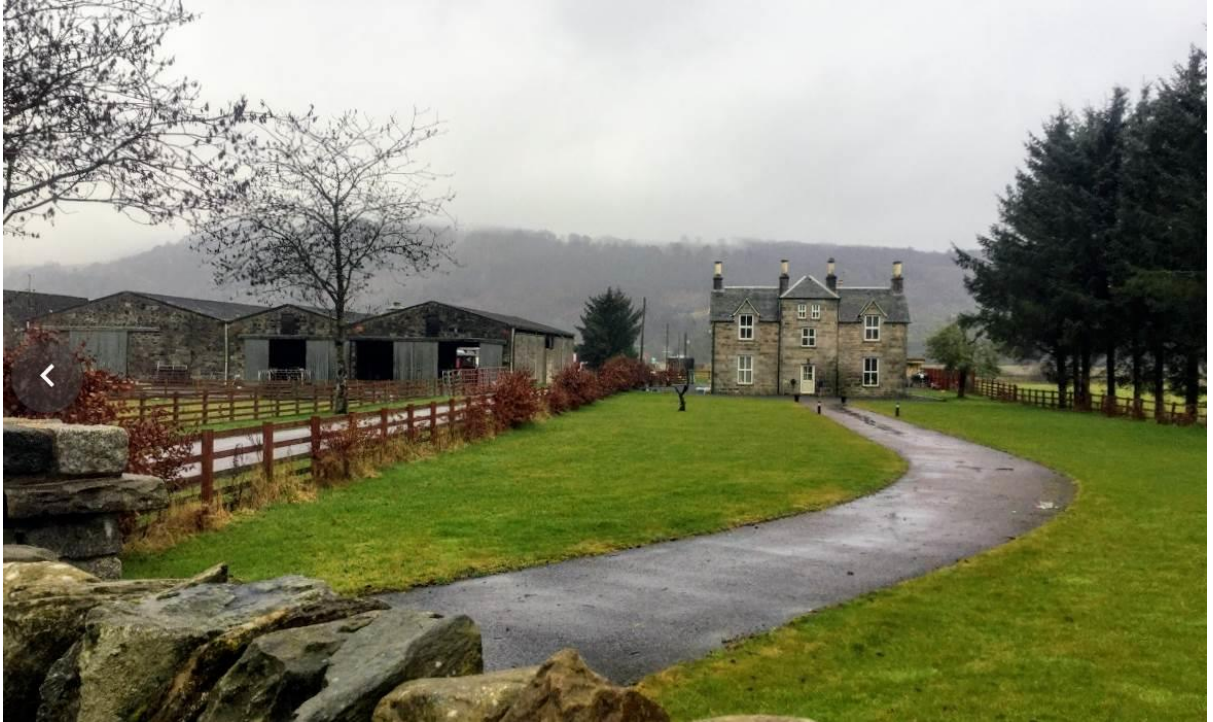
**Photograph 15.19: Westhaugh of Tulliemet Farmhouse (Asset 240) and Steading (Asset 238) viewed looking west from the A9**

comprising the understated symmetrical farmhouse (see Photograph 15.19), closely associated with the large-scale steading and associated horse gin (see Photograph 15.20).

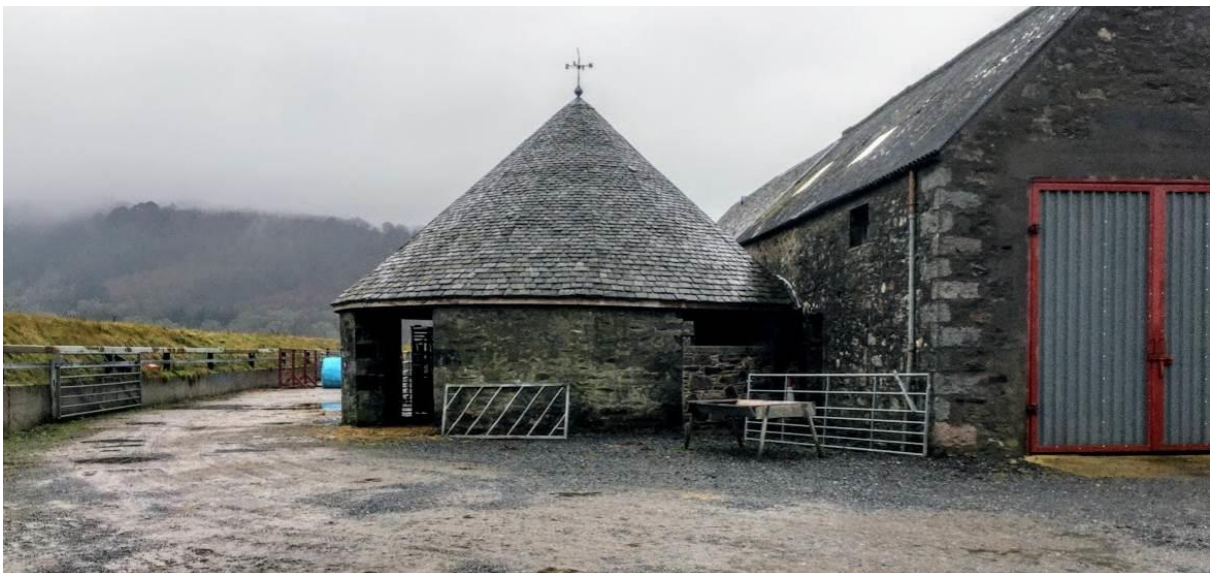
**Photograph 15.20: Westhaugh of Tulliemet Steading horse gin**

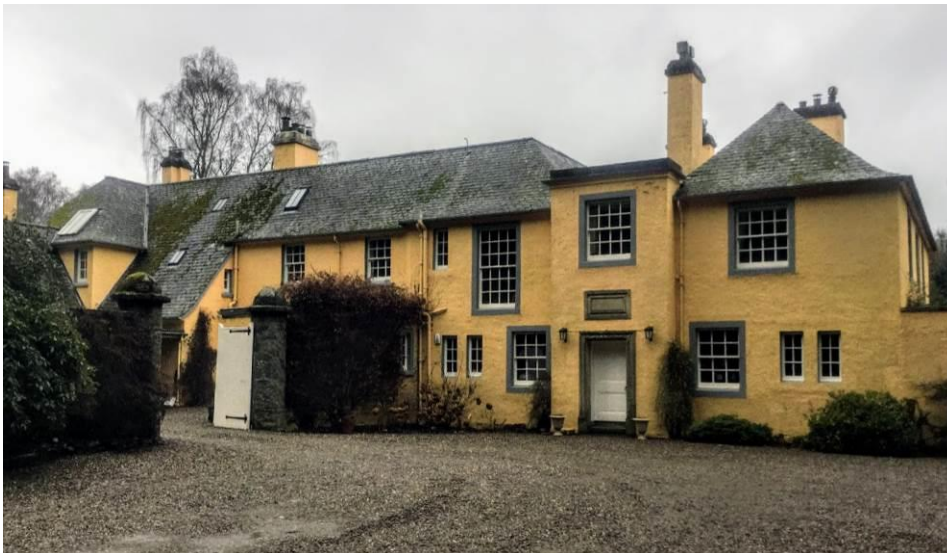
**Photograph 15.21: Cuil-an-Duin (Asset 237)**

- 15.3.78 Cuil-an-Duin (Asset 237) is a mansion in the Scots-Renaissance style dated to the 1920s (see Photograph 15.21). The house was sited to enjoy the surrounding landscape of Strath Tay, evidenced in its location on a hillslope high above the river, and its orientation to capitalise on views up and down the valley. The house is set within mature wooded grounds, with ornamental gardens surrounding the house. The principal elevation looks to the south-south-west, with a retaining wall used to create a lawned area in front of the house which would have enjoyed long views down the Tay valley, now screened by mature trees. Views to the west are also formally treated with an area of terraced grass creating a small amphitheatre leading to a centrally-placed gate which frames views westwards from the house, and provides access to the grounds beyond. The grounds reflect contemporary trends in gardening in the creation of a woodland garden and rhododendron garden, and continue to form an integral part of the asset's value today.

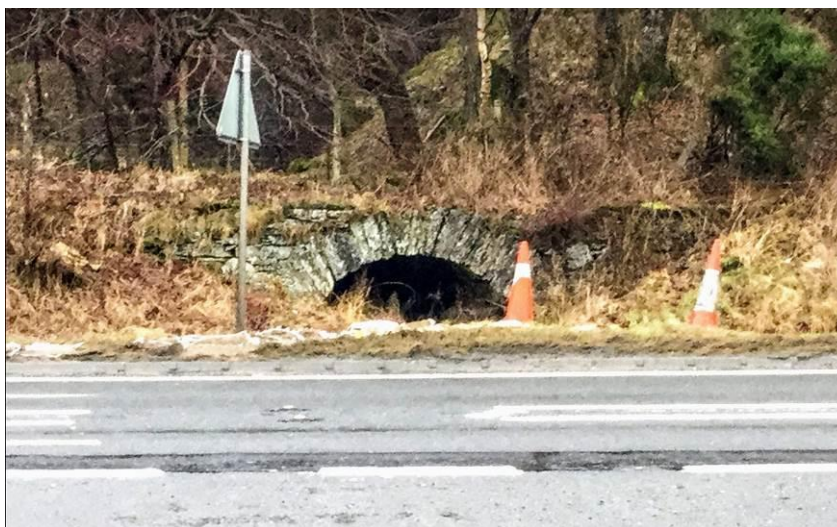
**Photograph 15.22: Possible military bridge/culvert near Westhaugh of Tulliemet (Asset 781)**

- 15.5.19 A Level 3 building record (Historic England, 2016) (**Mitigation Item P03-CH12**) will be undertaken of Westhaugh of Tulliemet Possible Military Bridge prior to construction to record the asset in its current condition. Level 3 provides an analytical record containing information obtained largely through an examination of the building itself and those documentary sources most readily accessible.

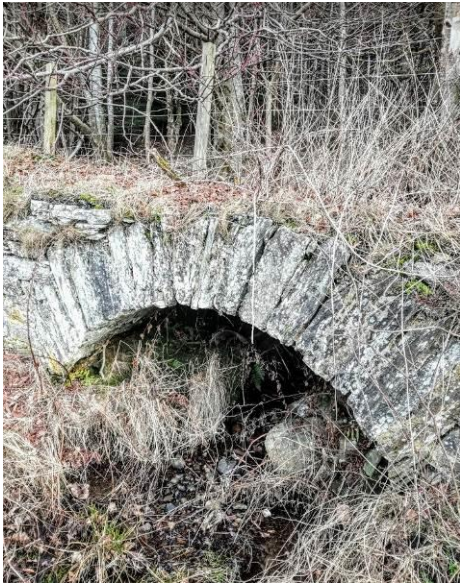
**Photograph 15.23: Detail of the span of the Possible military bridge/culvert near Westhaugh of Tulliemet**

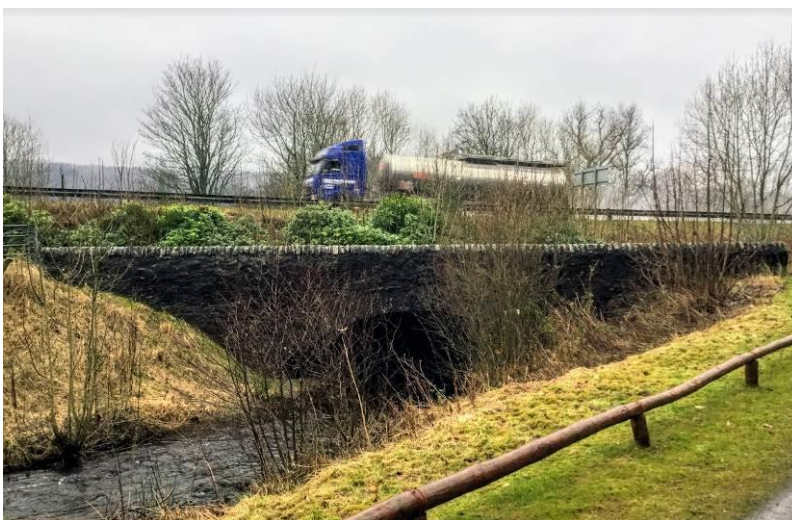
- 15.3.90 Taking into account its designation and preservation of fabric dating from the 18<sup>th</sup> century structure, Ledpettie Wade Bridge (Asset 194) has been assessed to be of medium value, Taking into account its association with Farnyhaugh Military Bridge (Asset 189) has also been assessed to be of medium value, while, as a later bridge with no known historic associations, Dowally Bridge (Asset 212) has been assessed to be of low value.

**Photograph 15.24: Dowally Bridge (Asset 212) with traffic movement on the existing A9 visible in the background**

- 15.4.24 Widening of the carriageway, and construction of the Dowally Burn Culvert and the Dowally - Kindallachan Side Road between ch4250 and ch4270 would result in the removal of Dowally Bridge. The potential impact on this low value asset has been assessed as of major magnitude and **Moderate** significance.

- 15.5.20 A Level 2 building record (Historic England, 2016) (**Mitigation Item P03-CH13**) will be undertaken of Dowally Bridge prior to construction to record the asset in its current condition. A Level 2 record makes a descriptive record comprising a drawn record, photographs and a written record.
